Housing Development,  
Mooreville, Rathdowney, Co Laois

Stage 1 Road Safety Audit

<b>Document Ref:</b>	<b>P20-060-RSA-PD-RP-001</b>
----------------------	------------------------------

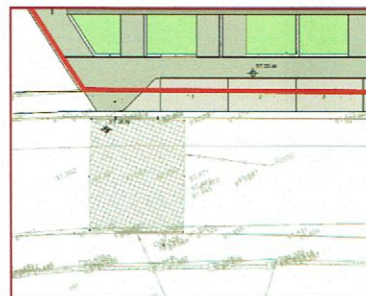
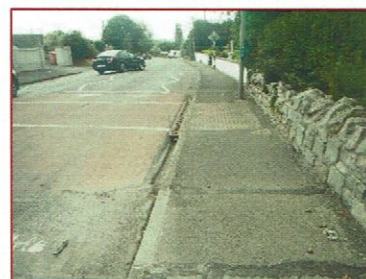
*Location: Drawing MV-ROD-00-XX-DR-C-0005 (Rev. P01)*

*Summary: Proposed parallel parking provision encroaches on the existing raised signalised pedestrian crossing on the R435.*

The proposed parallel parking is indicated in close proximity to and, in relation to space no. 1, encroaching onto the existing raised signalised pedestrian crossing on the R435. It is unclear if it is proposed to remove this crossing. If this crossing is not removed vehicles entering and exiting the parallel parking spaces, particularly spaces 1 and 2, will conflict with the operation of the crossing which could lead to driver discomfort as they ascend/descend the ramp or to collisions with vulnerable road users crossing the R435.

To facilitate the proposed parallel parking spaces the existing signalised crossing should be relocated.

3.1	Yes	Yes	Pedestrian crossing to be moved to north-west (approx. 2.5m) so the parking does not encroach on the crossing.	
3.2	Yes	Yes	The 3 No. spaces at the rear of the site will be assigned to each house, therefore only drivers who know the road should be using it. Cars will travel slowly on the road. Drivers at the top of the road (parking side) will give way to oncoming traffic (line markings and signage to be shown at detailed design stage). Mirrors to be included to provide drivers with enhanced sightlines.

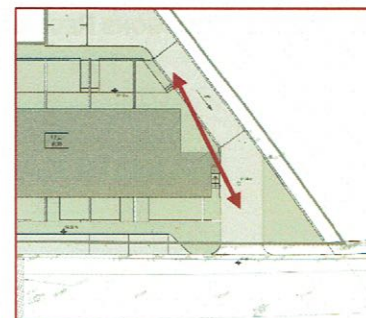
*Location: Drawing MV-ROD-00-XX-DR-C-0005 (Rev. P01)*

*Summary: It is unclear if there is sufficient space within the access road carriageway for safe two-way traffic.*

The width of the internal access road within the proposed development has not been specified and it is therefore unclear if the carriageway will be sufficiently wide enough for two vehicles to pass each other safely. The swept path drawings provided indicate that while sufficient space for two-way traffic may be available on the immediate approach to the site access it is unlikely that two vehicles will be able to pass each other safely within the carriageway adjacent the site's eastern boundary which could lead to low speed head-on collisions.

This problem may be exacerbated by the potential for the corner of the easternmost residential unit to restrict a driver's forward visibility thus increasing the risk of head-on collisions.

Ensure sufficient forward visibility is maintained within the development.

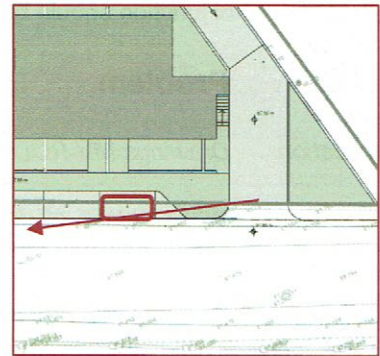
*Location: Drawing MV-ROD-00-XX-DR-C-0005 (Rev. P01)*

*Summary: Vehicles parked in the proposed parallel parking spaces may restrict a driver's visibility to the west when exiting the site.*

The proposed parallel parking spaces to the west of the site access, when occupied, may restrict a driver's visibility in this direction when exiting the site. This could lead to drivers exiting the site onto the R435 when it is unsafe to do so resulting in side-on collisions with vehicles on the R435.

Ensure vehicles parked in the parallel parking spaces do not impede a driver's visibility when exiting the site of the proposed development.

3.3	Yes	Yes	Car parking to move to north-west to provide sufficient sightlines (approx 2.5m).	
3.4	Yes	No	Laois CoCo have requested that the number of parking spaces be kept to a minimum.	Yes

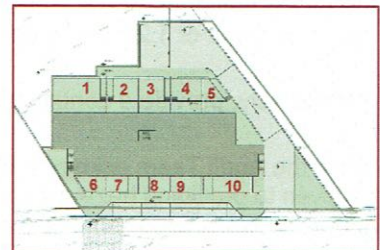
*Location: Drawing MV-ROD-00-XX-DR-C-0005 (Rev. P01)*

*Summary: It is unclear if the proposed parking provision will be sufficient for the number of residential units within the proposed development.*

A total of 7No parking spaces have been indicated within the proposed development, 3No on-curtilage spaces to the rear of the proposed residential units and 4No parallel parking spaces on the R435 adjacent the development. The number of units proposed within the development is unclear although the Audit Team have assumed that there will be a minimum of 10No units due to the number of accesses indicated within the site.

It is therefore unclear if the proposed parking provision will sufficiently cater for the number of residents and any visitors which may visit the development. If sufficient parking is not provided this could lead to residents, or visitors, parking in unsafe locations within the site or on the R435 resulting in an increased risk of collisions.

Ensure the proposed parking provision is sufficient for residents and visitors.

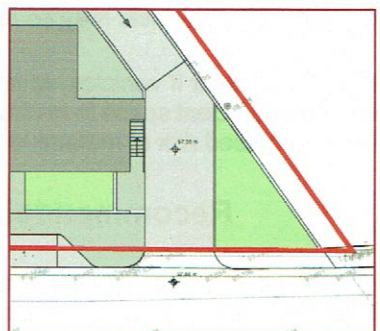
*Location: Drawing MV-ROD-00-XX-DR-C-0005 (Rev. P01)*

*Summary: Junction control has not been indicated at the junction of the site access and the R435.*

The control of the junction of the site access and the R435 has not been indicated. It is therefore unclear if the junction will operate under Stop, or Yield, control. Each type of junction control requires different visibility requirements on approach to the junction, with a Yield control junction requiring more onerous requirements. It is unclear if the visibility requirements for a Yield junction will be achieved on the approach due to the adjacent property boundary to the east and the proposed residential units to the west. If sufficient visibility, for the necessary type of junction control, is not provided this could lead to driver's being insufficiently aware of the junction on the approach, and the need to slow their vehicle or stop completely, with an increased risk of overshooting into the R435 carriageway and side-on collisions.

A Stop control junction should be provided at the site access.

3.5	Yes	Yes	Stop road markings and Stop signs to be shown on drawings at detailed design stage.	
3.6	Yes	Yes	Dropped kerbs and tactile paving to be provided on both sides of the crossing. They will be shown at detailed design stage.

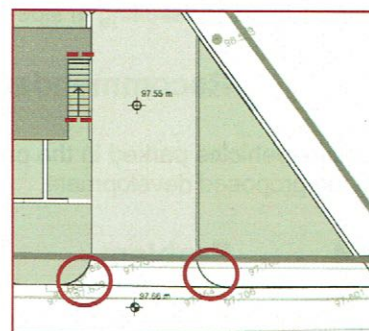
*Location: Drawings MV-ROD-00-XX-DR-C-0005 (Rev. P01) & MV-ROD-00-XX-DR-C-0070 (Rev. P01)*

*Summary: While details of dropped kerbs and tactile paving have been provided, they have not been indicated within the proposed development.*

While details of dropped kerbs and tactile paving have been provided, they have not been indicated within the proposed development. It is therefore unclear if they will be provided where necessary, for example at the crossing of the site access. A failure to provide dropped kerbs and tactile paving could lead to mobility impaired pedestrians being unable to descend the footpath when crossing the carriageway and to visually impaired pedestrians unknowingly entering the carriageway at a crossing with an increased risk of being struck by a vehicle.

Dropped kerbs and tactile paving should be provided on both sides of the crossing of the site access. Ensure the tactile paving is of the sufficient colour for an uncontrolled crossing and of the required depth (0.8m for inset crossings or 1.2m for inline crossings).

Alternatively, provide a continuous footway across the access, whereby drivers must yield to pedestrians.

While the Audit Team acknowledge that the residential units will be privately owned, consideration should also be given to providing hazard warning paving at the top and bottom of steps within the development, especially at any locations accessible by the public.

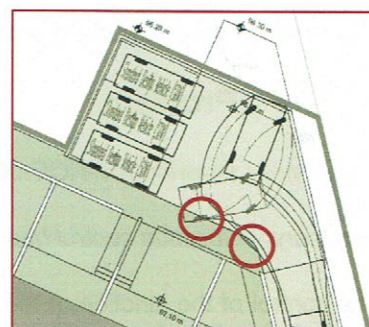
*Location: Drawing MV-ROD-00-XX-DR-C-0090 (Rev. P01)*

*Summary: Swept path of a reversing vehicle is indicated as mounting the footpath.*

The swept path analysis drawings indicate the wheel of a vehicle mounting the footpath at the rear of the proposed development when entering and reversing within the site. There is a risk of material damage to the kerb/footpath and vehicles should a vehicle mount/strike the footpath when reversing.

Also, there is an increased risk of collisions between vehicles and pedestrians should a vehicle overhang the footpath, particularly when undertaking a reversing manoeuvre as a driver's visibility to a pedestrian to the rear of their vehicle may be restricted.

It is also unclear if vehicles, which park nose-in at the 3No parking spaces to the rear of the residential units will have sufficient space to reverse out of a parking space if the adjacent parking spaces are occupied resulting in an increased risk of material damage collisions.

Ensure all vehicles can undertake turning manoeuvres within the proposed development safely without impeding on adjacent footpaths or striking other vehicles or boundary walls.

A swept path analysis should be undertaken to determine if all of the parking spaces are sufficiently accessible within the space available, particularly when adjacent spaces are occupied.

3.7	Yes	Yes	Turnabout area to be increased to allow more comfortable turning and to ensure all spaces are accessible.

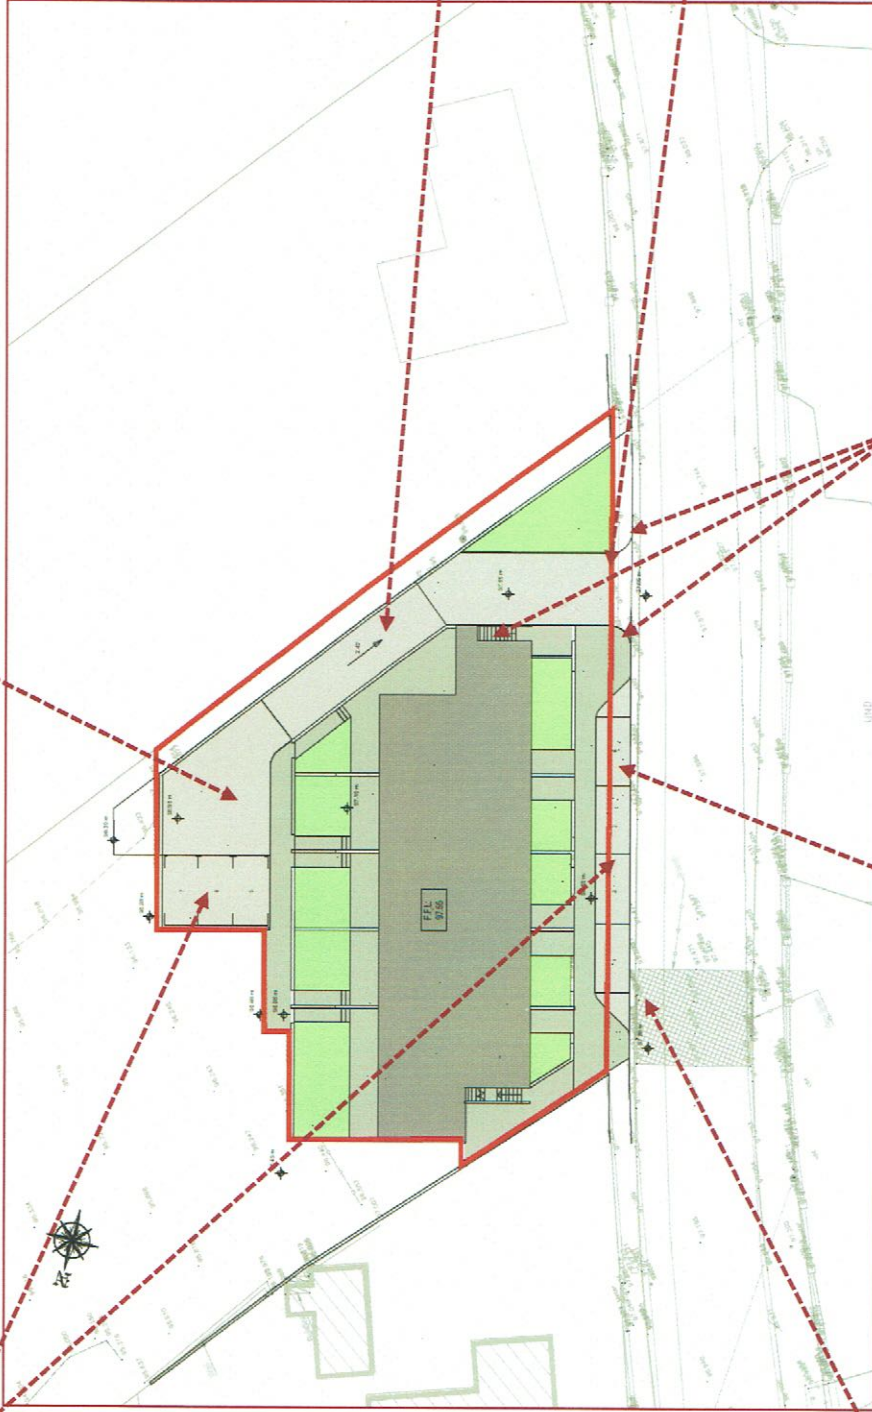
## Appendix D – Problem Locations

**Problem 3.4:** It is unclear if the proposed parking provision will be sufficient for the number of residential units within the proposed development.

**Problem 3.7:** Swept path of a reversing vehicle is indicated as mounting the footpath.

**Problem 3.2:** It is unclear if there is sufficient space within the access road carriage-way for safe two-way traffic.

**Problem 3.5:** Junction control has not been indicated at the junction of the site access and the R435.

**Problem 3.1:** Proposed parallel parking provision encroaches on the existing raised signalised pedestrian crossing on the R435.

**Problem 3.3:** Vehicles parked in the proposed parallel parking spaces may restrict a driver's visibility to the west when exiting the site.

**Problem 3.6:** While details of dropped kerbs and tactile paving have been provided, they have not been indicated within the proposed development.
