Lead Based Paint Inspection Report

Site Address	Old Courthouse Borris-in-Ossory Co. Laois
Site Location

Client	Name: Laois County Council Áras an Chontae JFL Avenue Portlaoise R32 EHP9 Contact: Ken Morley Instructing Party: Howley Hayes Architects, Patrick Tyrrell
Survey Dates	21/02/23
Issue Date	22/02/23
Surveyor(s)	John Kelleher, About Safety Ltd.

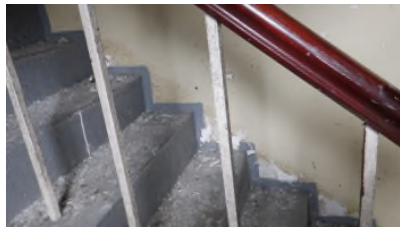
10.	Old Courthouse	East Wing Room 0.15	Stairway spindles	Paint	Metal	Flaking	<LOD	1.0

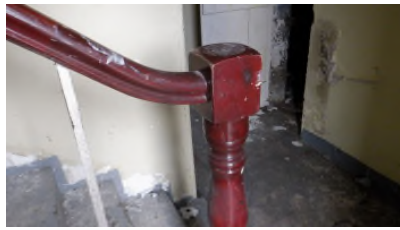
11.	Old Courthouse	East Wing Room 0.15	Stairway post	Paint	Timber	Intact	<LOD	1.0

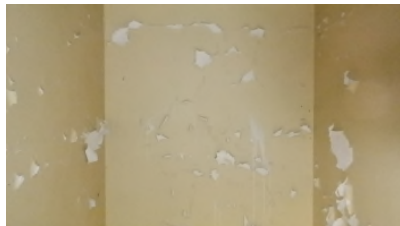
12.	Old Courthouse	East Wing Room 0.15	Walls	Paint	Plaster	Flaking	<LOD	1.0

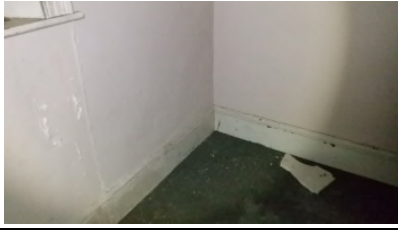
31.	Old Courthouse	East Wing Room 1.08	Skirting board	Paint	Timber	Intact	<LOD	1.0

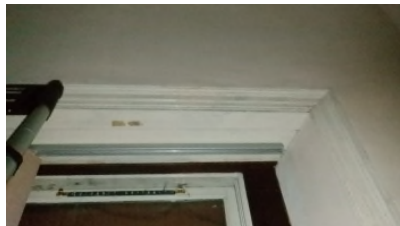
34.	Old Courthouse	East Wing Room 1.09	Window	Window frame	Timber	Intact	<LOD	1.0

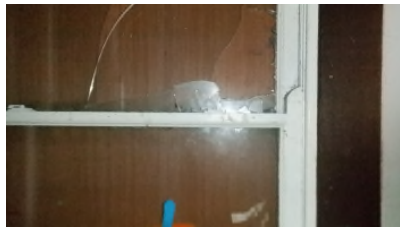
35.	Old Courthouse	East Wing Room 1.09	Window	Window bars	Timber	Intact	<LOD	1.0

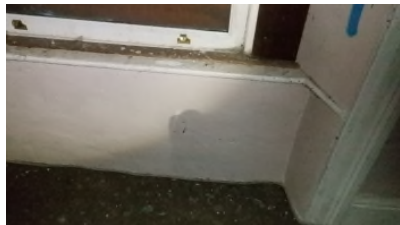
36.	Old Courthouse	East Wing Room 1.09	Window	Window board	Timber	Intact	<LOD	1.0

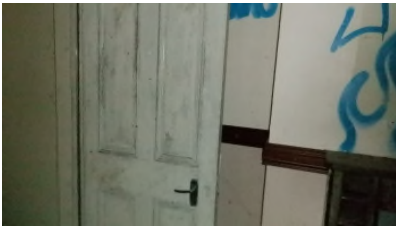
38.	Old Courthouse	East Wing Room 1.09	Door to Room 1.01	Door panel	Timber	Intact	<LOD	1.2

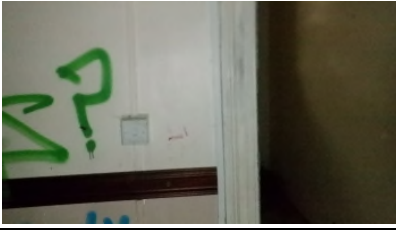
39.	Old Courthouse	East Wing Room 1.09	Door to Room 1.01	Architrave	Timber	Intact	<LOD	1.0

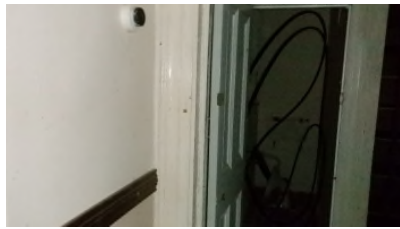
46.	Old Courthouse	East wing Ground floor Room 0.13	Door	Architrave	Timber	Intact	<LOD	1.0

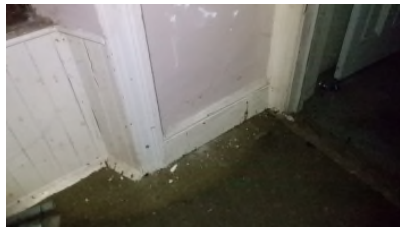
47.	Old Courthouse	East wing Ground floor Room 0.13	Floor	Skirting board	Timber	Intact	<LOD	1.0

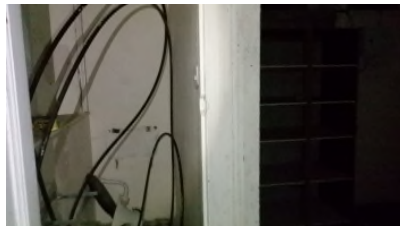
48.	Old Courthouse	East wing Ground floor Room 0.01	Door	Door frame	Timber	Intact	<LOD	1.0

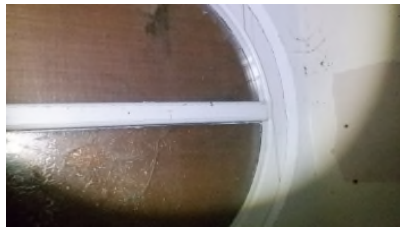
50.	Old Courthouse	East wing Ground floor Room 0.01	Window	Frame	Timber	Intact	<LOD	1.0

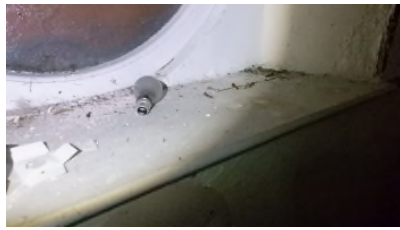
51.	Old Courthouse	East wing Ground floor Room 0.01	Window	Window board	Timber	Intact	<LOD	1.8

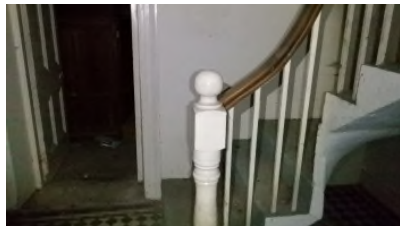
52.	Old Courthouse	East wing Ground floor Room 0.02	Stairway	Newel post	Timber	Intact	<LOD	1.0

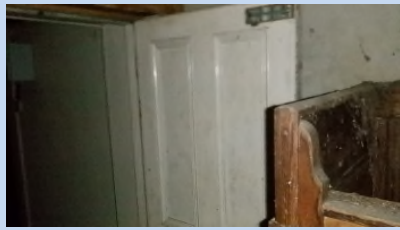
55.	Old Courthouse	Courtroom Door from 0.02	Door	Door	Timber	Intact	1.34	3.6

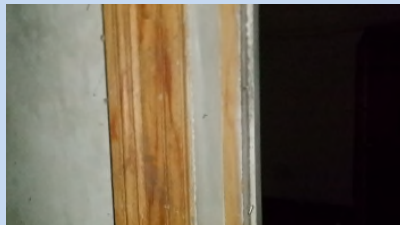
56.	Old Courthouse	Courtroom Door from 0.02	Door	Frame	Timber	Intact	6.39	1.4

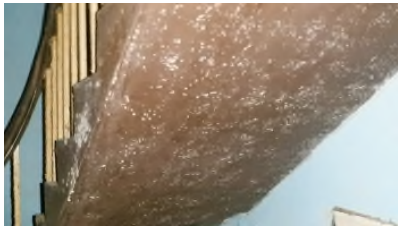
74.	Old Courthouse	West Wing Room 0.04	Under stairway	Paint	Plaster	Flaking	<LOD	1.0

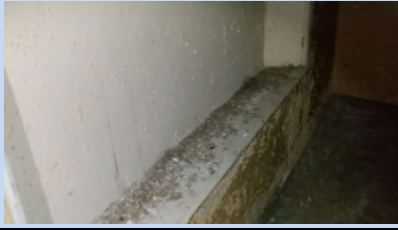
75.	Old Courthouse	West Wing 1 st floor Room 1.02	Blocked up window	Window board	Timber	Intact	1.89	3.9

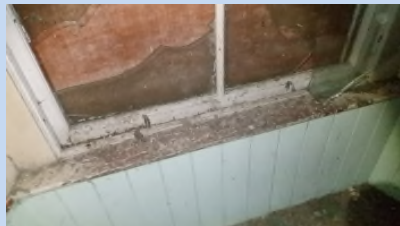
92.	Old Courthouse	West Wing 1 st floor Room 1.04	Window	Window board	Timber	Flaking	1.30	3.0

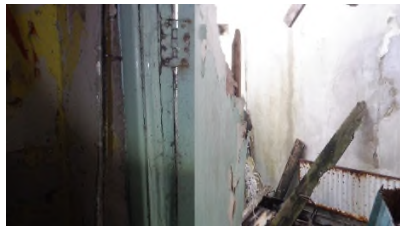
110.	Old Courthouse	West Wing Ground floor Room 0.08	Door	Frame	Timber	Flaking	<LOD	1.0

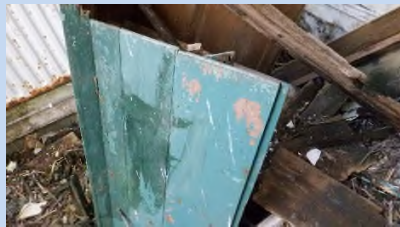
111.	Old Courthouse	West Wing Ground floor Room 0.09	Floor	Old blue painted boards	Timber	Flaking	1.83	1.7

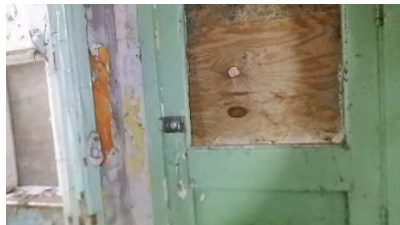
112.	Old Courthouse	West Wing Ground floor Room 0.08	Back door	Door	Timber	intact	<LOD	1.0
