Refurbishment & Demolition Asbestos Survey

Site Address	Old Courthouse Borris-in-Ossary Co. Laois
Site Location

Client	Name: Laois County Council Áras an Chontae JFL Avenue Portlaoise R32 EHP9 Contact: Ken Morley Instructing Party: Howley Hayes Architects, Patrick Tyrrell
Survey Dates	21/02/23
Issue Date	22/02/23
Surveyor(s)	John Kelleher, About Safety Ltd.

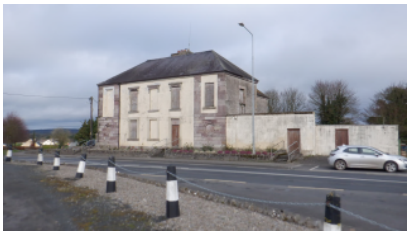
Ref No.	Building or Area of Site	Location or Functional Space	Sample No.	Material Description , surface treatment and condition	Extent	Asbestos identified (presumed, strongly presumed or identified)	Product type	Condition	Surface treatment	Asbestos type	Material assessment score	Recommendations	Photo
1.	Old Courthouse	Roofs		Natural quarry slates to main roofs generally.		NAD

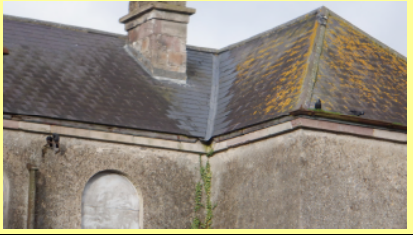
2.	Old Courthouse	Roof NW valley		Repair slates on the valley		Presumed asbestos						Investigation and sampling of suspect materials prior to work likely to cause disturbance.

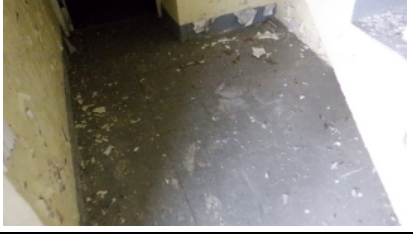
3.	Old Courthouse	Ground floor Room 0-15	2305201	Grey VFT and Evode		NAD

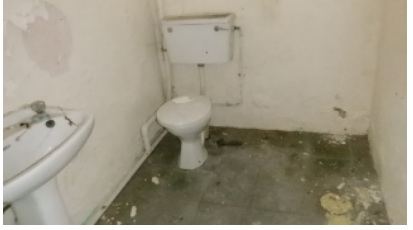
4.	Old Courthouse	Ground floor Room 0-13		Grey VFT and Evode		NAD

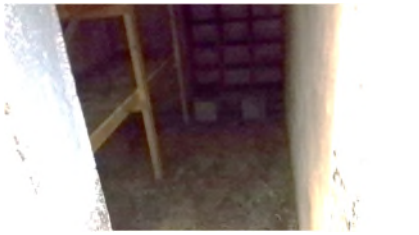
Ref No.	Building or Area of Site	Location or Functional Space	Sample No.	Material Description , surface treatment and condition	Extent	Asbestos identified (presumed, strongly presumed or identified)	Product type	Condition	Surface treatment	Asbestos type	Material assessment score	Recommendations	Photo
5.	Old Courthouse	Ground floor Room 0-12				NAD

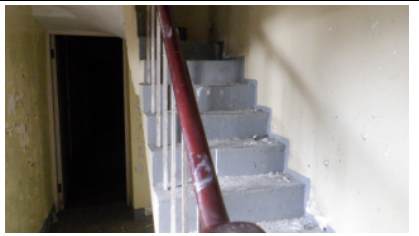
6.	Old Courthouse	Ground floor Room 0-15 Side entrance				NAD

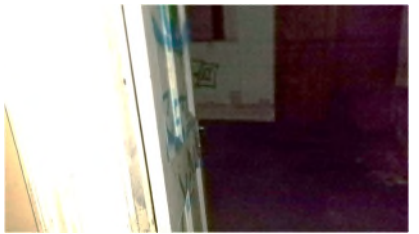
7.	Old Courthouse	1st floor East Wing Room 1-05				NAD

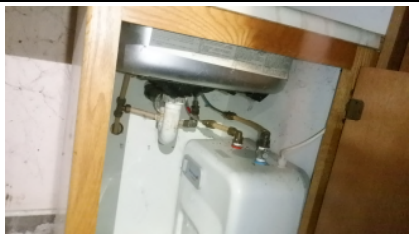
8.	Old Courthouse	1st floor East Wing Room 1-05	2305204	Bitumen pads to sink unit		NAD

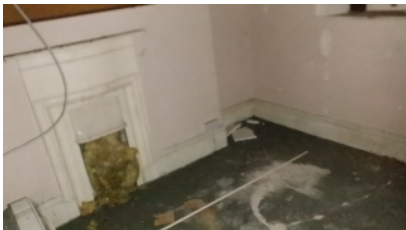
Ref No.	Building or Area of Site	Location or Functional Space	Sample No.	Material Description, surface treatment and condition	Extent	Asbestos identified (presumed, strongly presumed or identified)	Product type	Condition	Surface treatment	Asbestos type	Material assessment score	Recommendations	Photo
9.	Old Courthouse	1 st floor East Wing Room 1-08	2305203	Grey lino		NAD

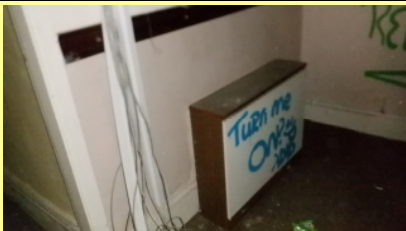
10.	Old Courthouse	1 st floor East Wing Room 1-09		Integral areas of old box radiator		Presumed asbestos						Investigation and sampling of suspect materials prior to work likely to cause disturbance.

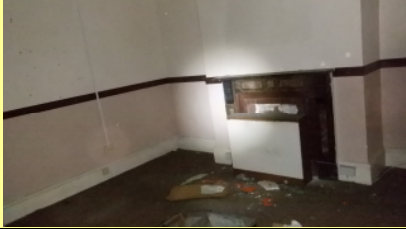
11.	Old Courthouse	Ground floor East Wing 0-13		Integral areas of old box radiator		Presumed asbestos						Investigation and sampling of suspect materials prior to work likely to cause disturbance.

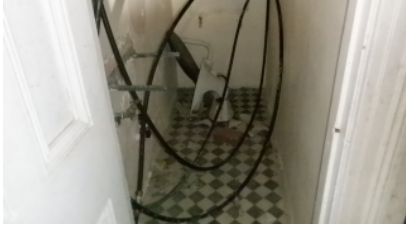
12.	Old Courthouse	Ground floor East Wing Room 0-13		Ceramic tiles on floor.		NAD

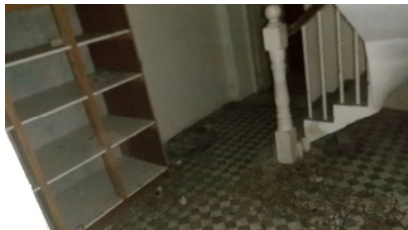
13.	Old Courthouse	Ground floor East Wing Room 0-02		Ceramic tiles on floor.		NAD

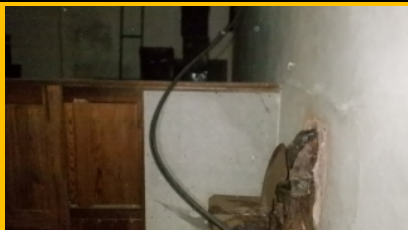
14.	Old Courthouse	Ground floor Courtroom Rm.- 0.03	2305202	AC sheeting to side of stove	Circa 1 SM	Chrysotile						Removal and disposal as asbestos waste by a competent contractor prior to work likely to cause disturbance.

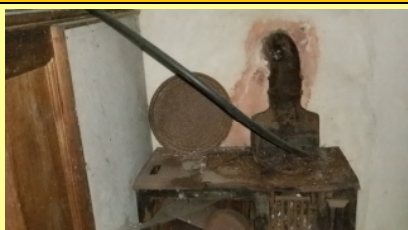
15.	Old Courthouse	Ground floor Courtroom Rm.- 0.03		Integral areas of old stove		Presumed asbestos						Investigation and sampling of suspect materials prior to work likely to cause disturbance.

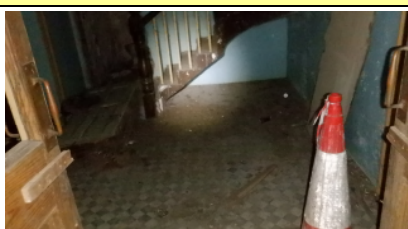
16.	Old Courthouse	Ground floor West wing Porch 0-04		Ceramic tiles on floor		NAD

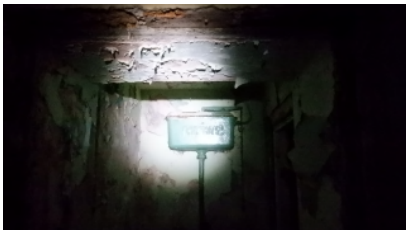
17.	Old Courthouse	Ground floor West wing WC 0-05		Metal cistern		NAD

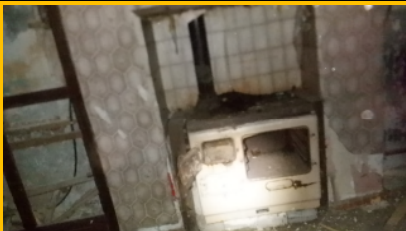
18.	Old Courthouse	Ground floor Kitchen Rm. 0.06	2305205	Red VFT under lino	Circa 20 SM	Chrysotile						Removal and disposal as asbestos waste by a competent contractor prior to work likely to cause disturbance.

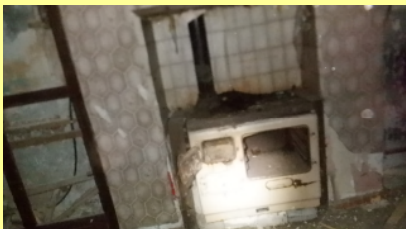
19.	Old Courthouse	Ground floor Kitchen Rm. 0.06		Integral areas of Stanley range and flue		Presumed asbestos						Investigation and sampling of suspect materials prior to work likely to cause disturbance.

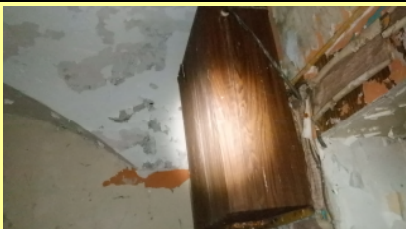
20.	Old Courthouse	Ground floor Off Kitchen Rm. 0.07		Integral areas of Stanley range and flue		Presumed asbestos						Investigation and sampling of suspect materials prior to work likely to cause disturbance.

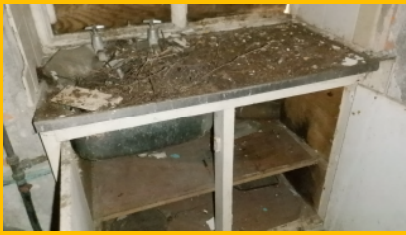
Ref No.	Building or Area of Site	Location or Functional Space	Sample No.	Material Description, surface treatment and condition	Extent	Asbestos identified (presumed, strongly presumed or identified)	Product type	Condition	Surface treatment	Asbestos type	Material assessment score	Recommendations	Photo
21.	Old Courthouse	Ground floor Off Kitchen Rm. 0.07	2305208	Bitumen sink pads		Chrysotile						Removal and disposal as asbestos waste by a competent contractor prior to work likely to cause disturbance.

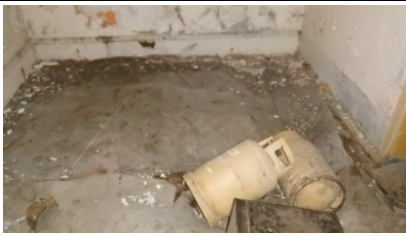
22.	Old Courthouse	Ground floor Off Kitchen Rm. 0.07	2305207	Linols		NAD

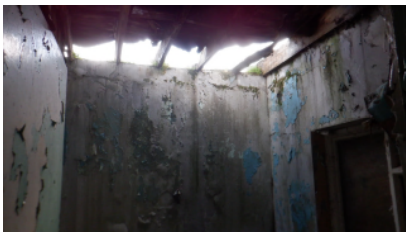
23.	Old Courthouse	Ground floor Room 0-09	2305210	Roofing felts		NAD

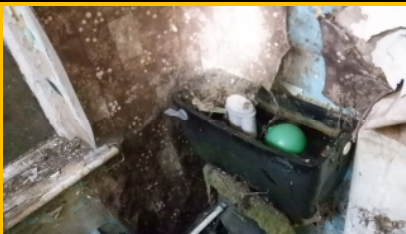
24.	Old Courthouse	Ground floor Room 0-10	2305209	Black Bakelite cistern and lid	1 unit	Amosite						Removal and disposal as asbestos waste by a competent contractor prior to work likely to cause disturbance.

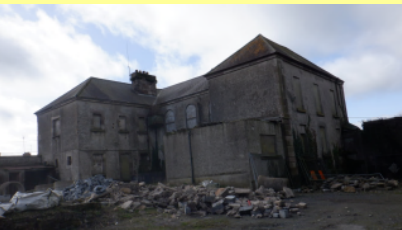
Ref No.	Building or Area of Site	Location or Functional Space	Sample No.	Material Description, surface treatment and condition	Extent	Asbestos identified (presumed, strongly presumed or identified)					Material assessment score	Recommendations	Photo
						Product type	Condition	Surface treatment	Asbestos type				
25.	Old Courthouse	External East Wing Rooms 0-11, 14 & 16		No access		Presumed asbestos						Investigation and sampling of suspect materials prior to work likely to cause disturbance.
