Independent Tree Surveys

Tree Survey Report

Carraig Glas
Stradbally
Co. Laois

November 2019

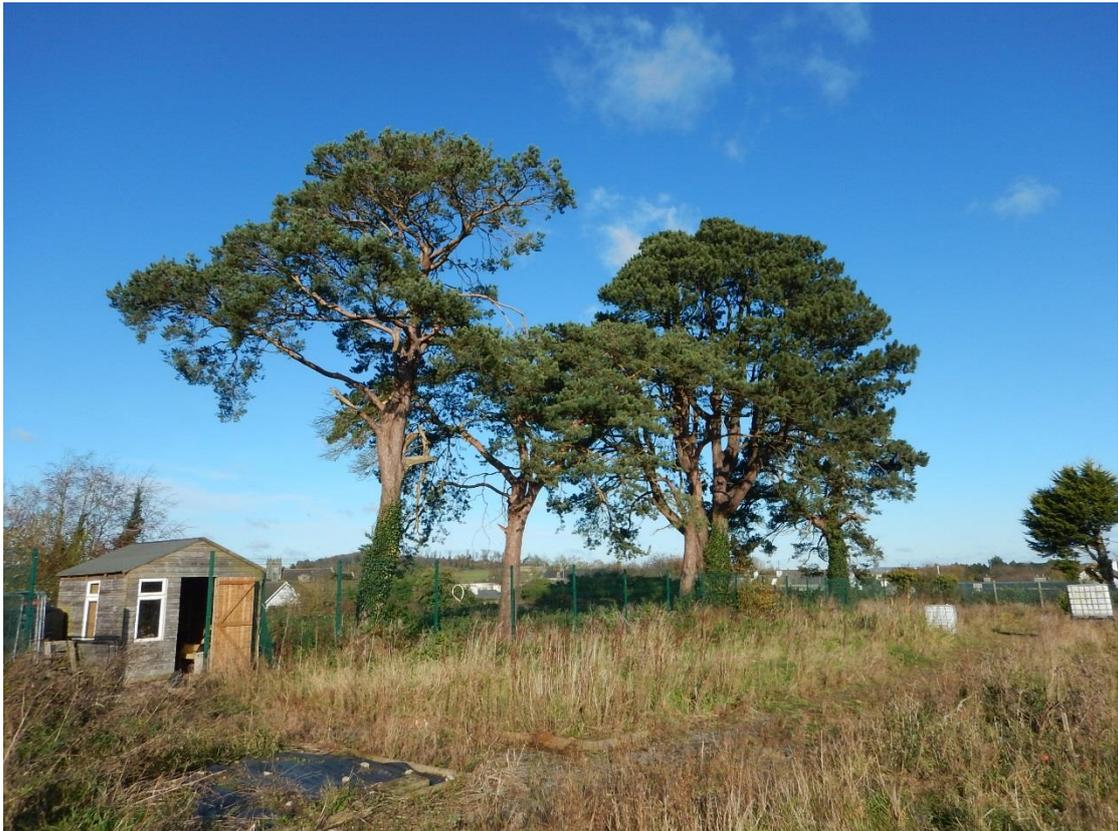
The most significant trees included in the schedule are the row of mature Pine trees tagged 18-22; these trees form a linear group along the northern fence-line of the former enclosed garden area and have a strong visual presence in the northern part of the site. The trees are of variable quality and value, with all of the trees likely to have sustained some level of root damage during past works within their root zones. The largest tree (tagged 19) is in fairly good physiological health; however, it is of questionable structural integrity, with a definite defect observed in the base of the union as the main stem forks into two at 2-3m from ground level.

The southernmost Pine tree (tagged 22) is showing clear signs of physiological stress, with the upper half of the tree crown now noticeably sparse and depleted.

1. Prominent Pine trees tagged 18-22 in the north-western part of the site

| No. | Species | Age | Ht m | Dbh mm | St | Cr | N | S | E | W | ERC | Phys Cond | Structural Condition/Comments | Preliminary Recommendations | RPA m | Area m2 | Cat |
|---|---|---|---|---|---|---|---|---|---|---|---|---|--|---|---|---|---|
| T18 | Pinus sylvestris (Scots Pine) | M | 15 | 800 | 1 | 2 | 7.5 | 4 | 4.5 | 5.5 | 20+ | Good | Fair. Medium sized Pine tree of reasonable form. Historic loss of limb from 6m on south side, plus some smaller broken branches in crown. Thick Ivy on tree stem, some Elm suckering around stem base. Scattered minor deadwood in crown. Possible root damage from works around tree as garden, fence and compacted gravel surfacing developed nearby. | Crown clean to remove broken or larger dead branches and branch stubs. Decompact rootzone and mulch. | 9.6 | 290 | B2 |
| T19 | Pinus nigra (Austrian Pine) | M | 18.5 | 1100 | 1 | 3 | 6.5 | 7 | 8 | 6.5 | 10+ | Good | Fair/Poor. Largest tree in linear group. Good vitality with full crown and no obvious dieback or disease. Main stem forks into two secondary stems at 2-3m with reaction growth/swelling evident on both sides (north and south) of stem. Indications of a crack/flaw below the compression fork on the north side with signs of wound wood production on either side of crack. Several other potentially weak unions in crown. Ivy growth on tree stem. Possible root damage from works around tree as garden and fence constructed nearby. | Crown clean and sever Ivy. Decompact rootzone and mulch. Review union at 2-3m and consider installation of bracing system if tree retained. Tree not suited to retention within high occupancy development. | 13.2 | 547 | C2 |
| T20 | Pinus sylvestris (Scots Pine) | EM | 12.5 | 600 | 1 | 3 | 3.5 | 2 | 4.5 | 5 | 10+ | Fair | Fair. Smaller Pine somewhat suppressed by neighbouring tree. Poor form and unbalanced crown shape. Tree vitality appears fairly good. Slightly swollen lower stem and wood decay evident in old bark wound on south side at 2.5m. Some deadwood in crown. Possible root damage from works around tree as garden and fence constructed nearby. | Crown clean to remove deadwood. Decompact rootzone and mulch. Monitor tree condition. | 7.2 | 163 | C2 |
| T21 | Pinus sylvestris (Scots Pine) | EM | 12 | 565 | 1 | 2.5 | 5 | 5.5 | 5 | 3.5 | 10+ | Fair | Fair. Smaller tree with a main stem that forks into two at 4m; union appears stable. Somewhat unbalanced crown shape. Minor deadwood and some minor dieback of fine branching in crown. Possible root damage from works around tree as garden and fence constructed nearby. | Crown clean to remove deadwood. Decompact rootzone and mulch. Monitor tree condition. | 6.78 | 144 | C2 |
| T22 | Pinus sylvestris (Scots Pine) | EM | 14 | 600 | 1 | 5 | 4 | 3 | 4 | 5 | 10 | Poor | Medium sized tree at south-western end of tree-line. Low vitality indicated by low bud/leaf density in upper crown giving a sparse appearance. Several broken branches in crown, with large branch hanging from around 10m. Tree close to garden shed and fenceline and likely to have sustained some root damage from the adjacent works. | Crown clean to remove deadwood. Decompact rootzone and mulch. Monitor tree condition. | 7.2 | 163 | C2 |

Should the site be developed and the land use changes include a significant increase in site occupancy by people, roads, buildings etc. the merits of the retaining the mature Pine trees are questionable. If their retention is strongly desired, then I would recommend that they are incorporated into green space well away from any new structures or roads etc. In my view they would not be suited to inclusion within highly modified environments such as roadside verges, hard surfacing or paving for example.

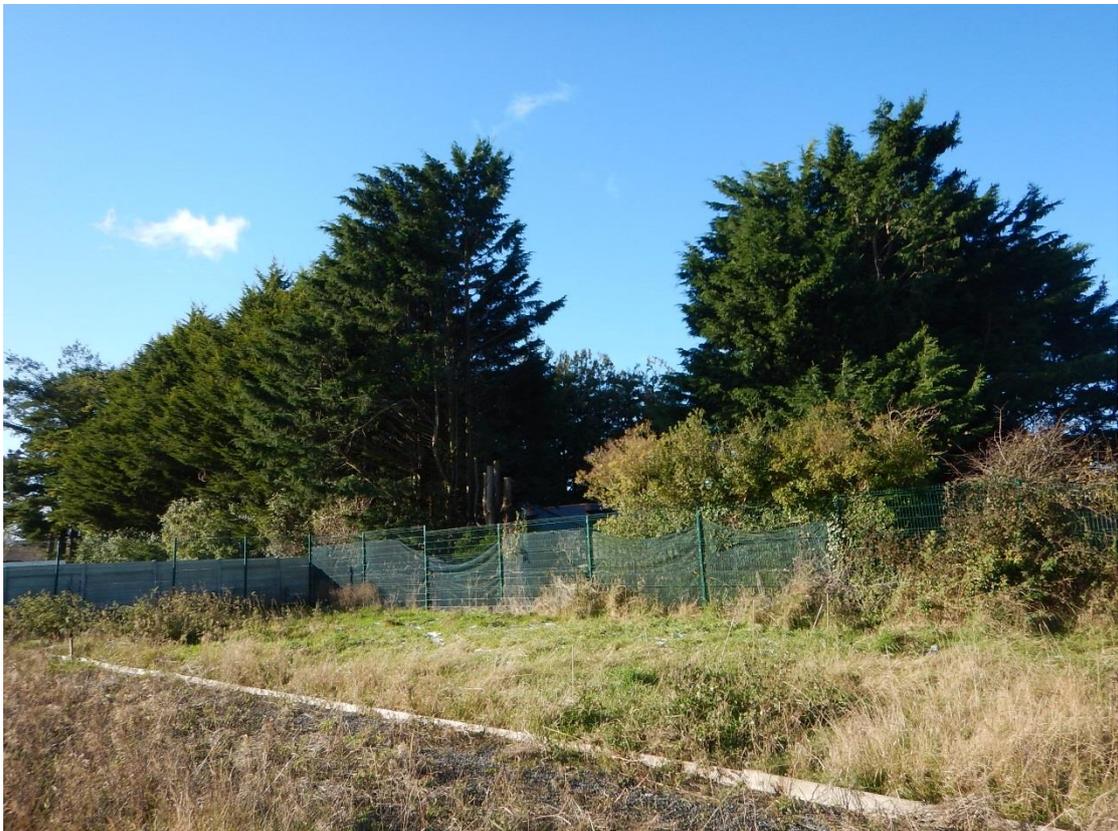
2. Cypress trees making up group G5 outside the site boundary

| No. | Species | Age | Ht m | Dbh mm | St | Cr | N | S | E | W | ERC | Phys Cond | Structural Condition/Comments | Preliminary Recommendations | RPA m | Area m ² | Cat |
|---|---|---|---|---|---|---|---|---|---|---|---|---|--|--|---|---|---|
| G5 | X Cupressocyparis leylandii (Leyland Cypress) | EM | 15 | 300 | 1 | 2 | 3.5 | 3.5 | 3.5 | 3.5 | 10+ | Fair | Fair/Poor. Linear planting of Cypress around the perimeter of neighbouring garden. Trees now quite sizeable and prone to breakage following previous topping at 3m or so. Some potentially weak unions in crown structure. Some broken branches in crown. Some branch spread out over boundary line into site (3-4m). Trees becoming sparse in the lower 2-3m, limiting the screening effect. A short section of trees in the corner area have been felled or severely cut back. | Target prune broken/damaged branches. Prune to reduce extended branches. | 3.6 | 40.7 | C2 |

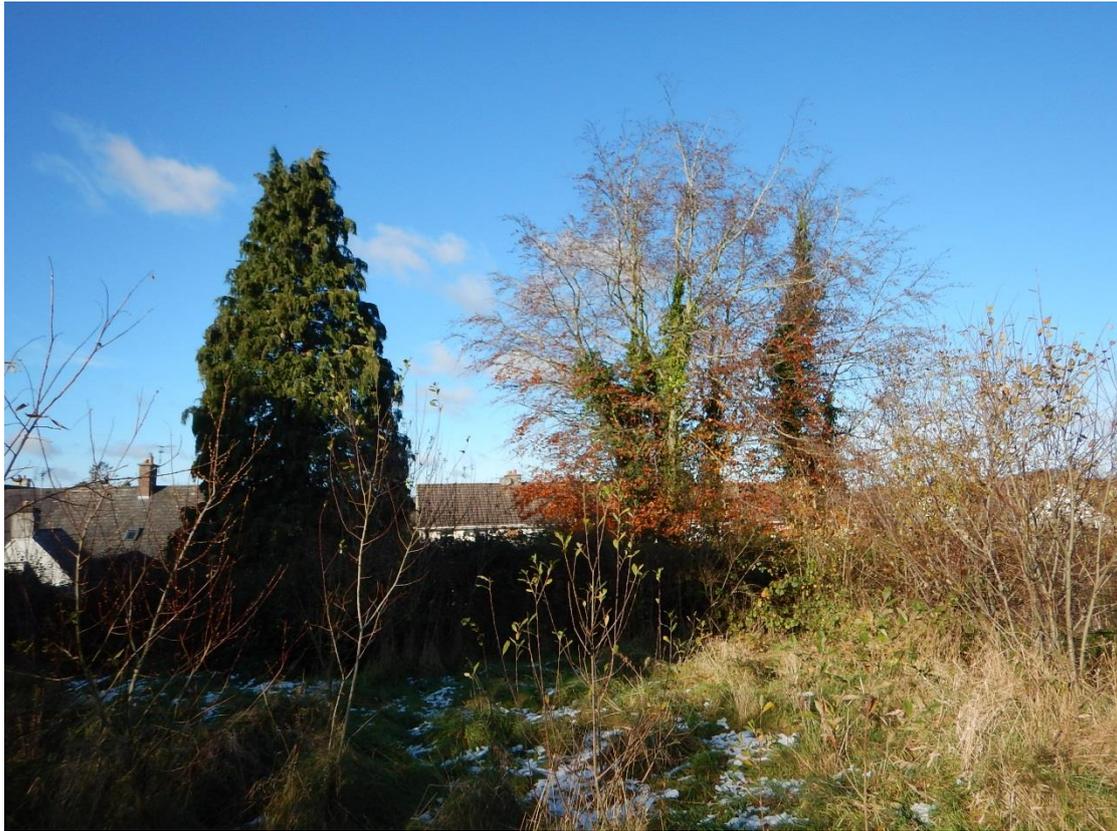
3. Cluster of Beech trees (group G3) and Lawson Cypress T28 along the northern boundary of the site.

| No. | Species | Age | Ht m | Dbh mm | St | Cr | N | S | E | W | ERC | Phys Cond | Structural Condition/Comments | Preliminary Recommendations | RPA m | Area m2 | Cat |
|---|--|---|---|---|---|---|---|---|---|---|---|---|---|---|---|---|---|
| T28 no tag | Chamaecyparis lawsoniana (Lawson Cypress) | EM | 9 | 300 | 1 | 0 | 2 | 2 | 2 | 2 | 10+ | Good | Fair/Poor. Conifer in neighbouring property. Compression fork on main stem and some potentially weak unions in crown structure. | No urgent works needed. | 3.6 | 40.7 | C2 |

| No. | Species | Age | Ht m | Dbh mm | St | Cr | N | S | E | W | ERC | Phys Cond | Structural Condition/Comments | Preliminary Recommendations | RPA m | Area m ² | Cat |
|---|---|---|---|---|---|---|---|---|---|---|---|---|--|--|---|---|---|
| G3 | Fagus sylvatica (Beech) | SM | 10 | 250 | 1 | 1 | 2.5 | 2.5 | 2.5 | 2.5 | 10+ | Fair | Fair. Short linear group of young Beech trees; probably the result of a section of Beech hedge being left uncut. | No urgent works needed. | 3 | 28.3 | C2 |

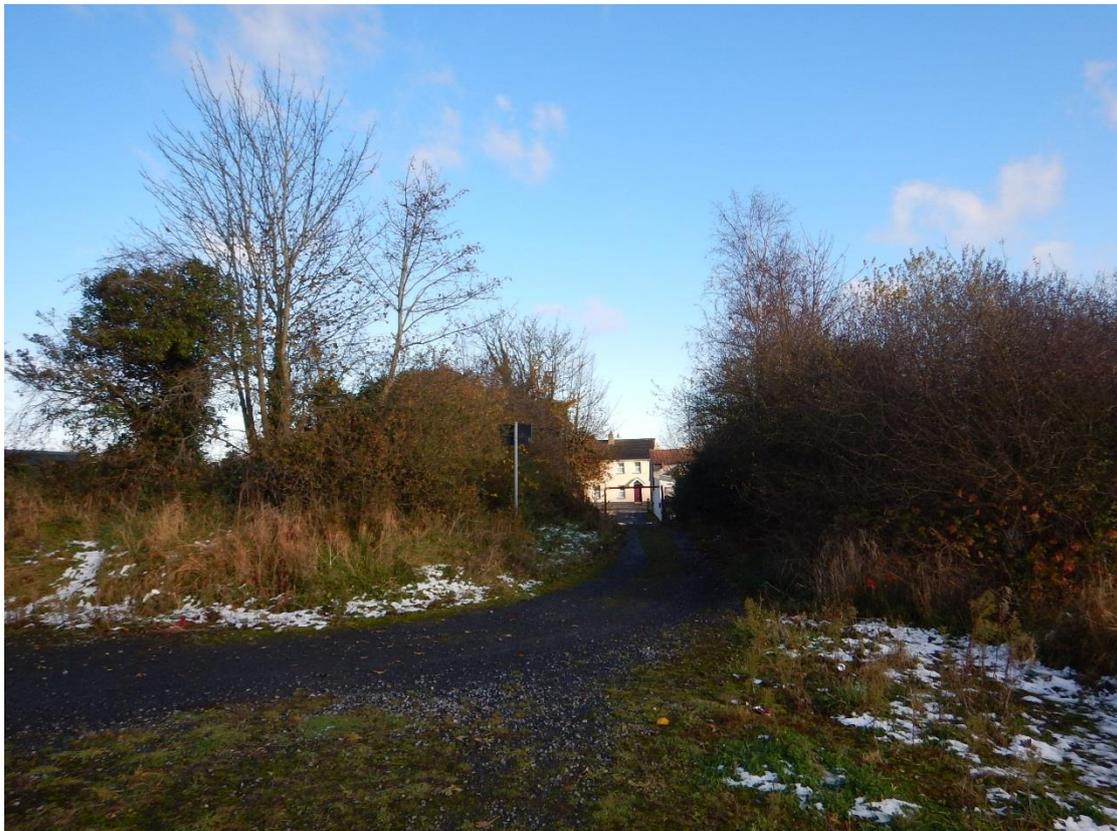
4. Access drive into site viewed from the south, with group G2 to right and hedge H6 to left

| No. | Species | Age | Ht m | Dbh mm | St | Cr | N | S | E | W | ERC | Phys Cond | Structural Condition/Comments | Preliminary Recommendations | RPA m | Area m ² | Cat |
|---|---|---|---|---|---|---|---|---|---|---|---|---|--|---|---|---|---|
| H6 | Crataegus monogyna (Hawthorn) Fraxinus excelsior (Ash) Prunus spinosa (Blackthorn) Sambucus nigra (Elder) Ulmus glabra (Wych Elm) Acer pseudoplatanus (Sycamore) | SM | 5 | 200 | 1 | 0 | 2 | 2 | 2 | 2 | 10 | Fair/Poor | Fair/Poor. Remnant hedge along side of access track, now in poor condition due to lack of maintenance and disease. Some young Elm suffering from Dutch Elm Disease. | Coppice weaker/selected stems to form basis of manageable hedge. | 2.4 | 18.1 | C2 |

| No. | Species | Age | Ht m | Dbh mm | St | Cr | N | S | E | W | ERC | Phys Cond | Structural Condition/Comments | Preliminary Recommendations | RPA m | Area m ² | Cat |
|---|---|---|---|---|---|---|---|---|---|---|---|---|--|--|---|---|---|
| G2 | Prunus spinosa (Blackthorn) Salix caprea (Goat Willow) | Y | 3 | 100 | 1 | 0 | 1 | 1 | 1 | 1 | 10+ | Fair | Fair. Dense natural regeneration of Blackthorn suckering along with some young Willow saplings spreading out into abandoned garden from boundary area. | No urgent works needed. | 1.2 | 4.52 | C2 |
