**20022-01-001**

**Proposed Residential Development at  
Railway Street, Portlaoise.**

**ROAD SAFETY AUDIT STAGE 1/2**

**March 2020**

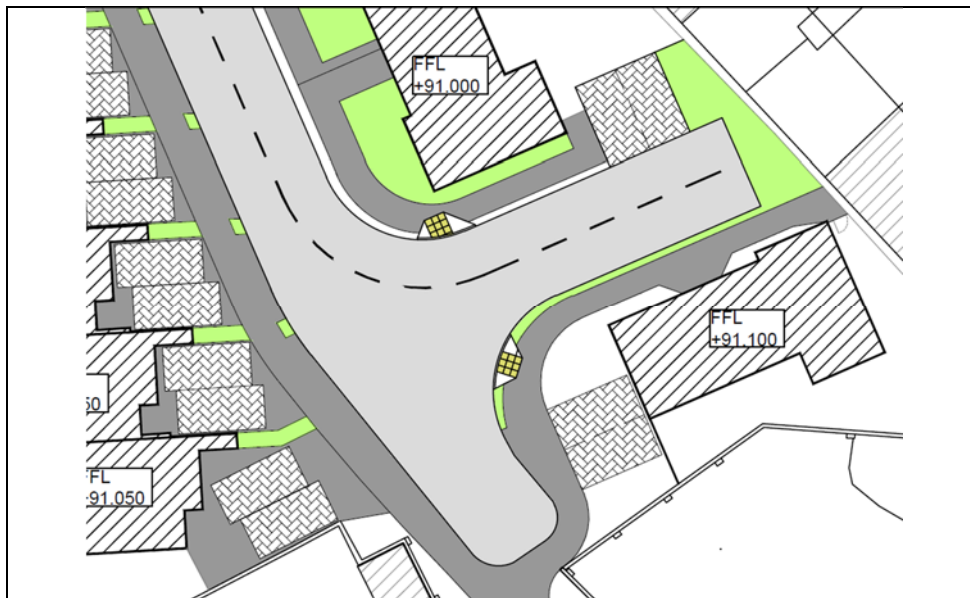
The priority of the southeast cul-de-sac/hammerhead within the development is unclear due to lack of appropriate/adequate road signage and markings. This may lead to driver confusion at the junction as to who has right of way which may contribute to a collision.

*Photo 1: No Priority Control at Southeast cul-de-sac/hammerhead.*

Provide yield road markings and signage on the most appropriate arm of this cul-de-sac/hammerhead.

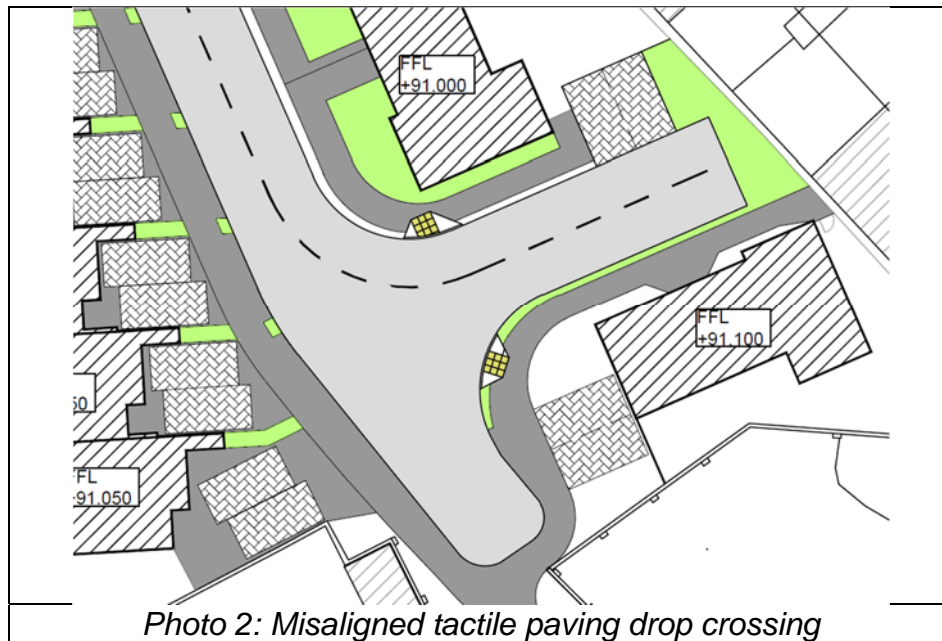
The proposed tactile paving drop crossing are not aligned with each other. This may lead to pedestrians, particularly the visually impaired, being guided into the junction mouth where they could be struck by approaching vehicles or directed towards a full height kerbline where they could trip and fall over same.

Align all proposed drop crossings within the development so that they do not pose a road safety issue for pedestrian especially, the mobility and visually impaired.

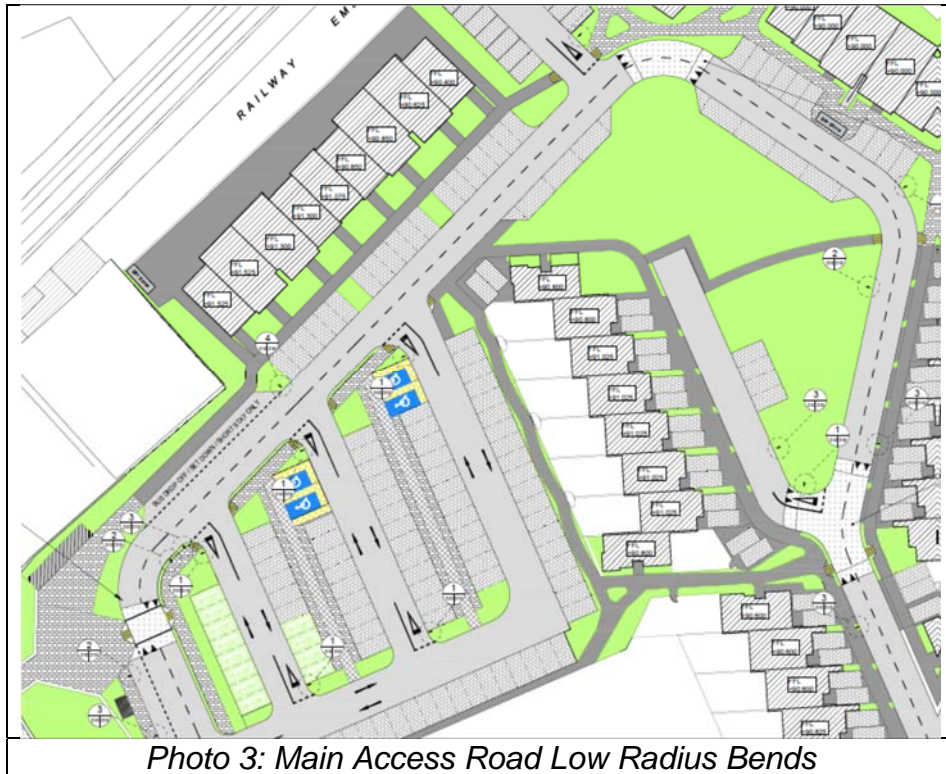
Low radii bends are proposed at a number of locations along the development's main access road. Two vehicles may have difficulty in passing one another on these bends which may lead to a side swipe collision. Stopping sight distance at these bends may also be restricted by vehicles parked in visitor parking bays near the bends which may contribute to a collision.

*Photo 3: Main Access Road Low Radius Bends*

Revise the layout at the bends to ensure that two vehicles can safely pass one another, and that adequate stopping sight distance is provided throughout.

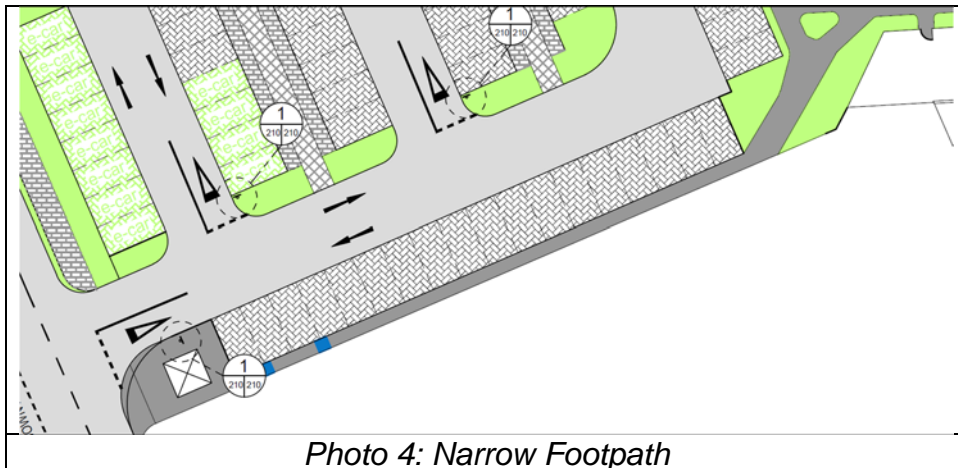
The proposed width of the Main Public Transport Carpark's southern footpath appears to be very narrow and may not cater for mobility impaired pedestrians. As a result, such pedestrians may be forced onto the carriageway or into parking areas where they would be at an increased risk of being struck by a passing vehicle.

*Photo 4: Narrow Footpath*

Provide adequate footway widths throughout the proposed development.

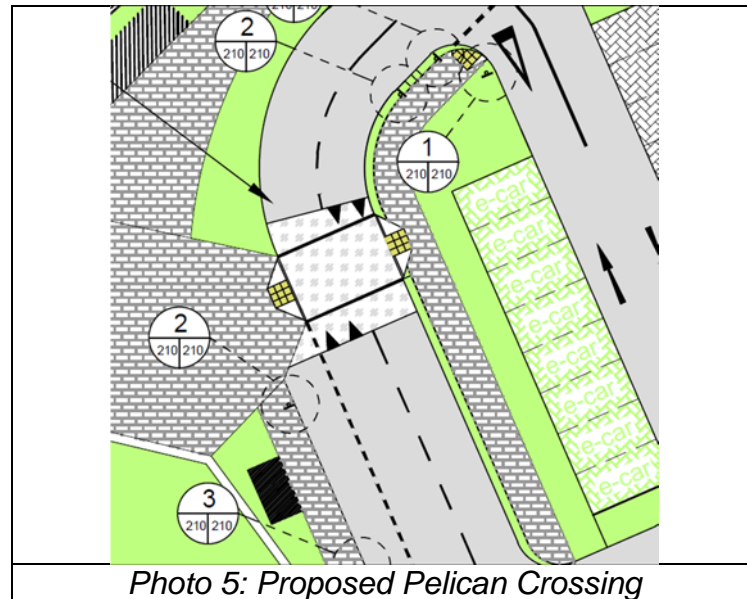
Due to the location of the proposed controlled pedestrian crossing (i.e. at a bend) the visibility of the traffic signal heads maybe restricted particularly for southbound approaching driver how may fail to see a red traffic signal and stop in time without colliding with a crossing pedestrian. In addition, the proposed road markings and tactile paving are not compatible with a controlled pedestrian crossing which may lead to further collisions due to driver and pedestrian confusion.

Move the pedestrian crossing to the bend so that the traffic signal heads will be clearly visible to approaching drivers on both approaches to the signalised crossing. In addition, provide the appropriate road markings and tactile paving for use at a signalised crossing.

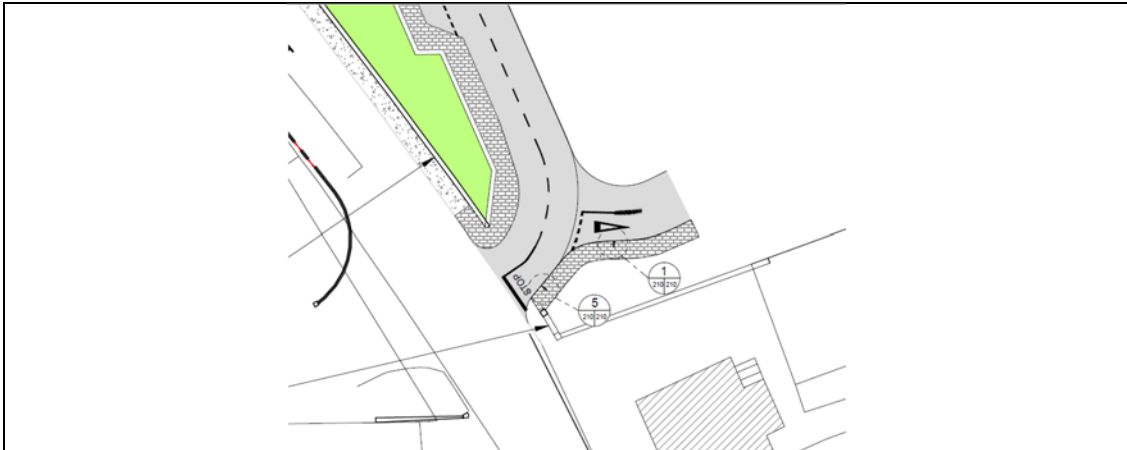
Pedestrian crossing facilities are not shown to be provided for pedestrians across the junction mouth at the access to the proposed development from Railway Station. A lack of adequate pedestrian crossing facilities may contribute to a pedestrian injury at this location.

*Photo 6: Omitted Dropped Crossing & Tactile Paving at Development Access*

Provide dropped kerbs and tactile paving at the access to the proposed development from Railway Station.

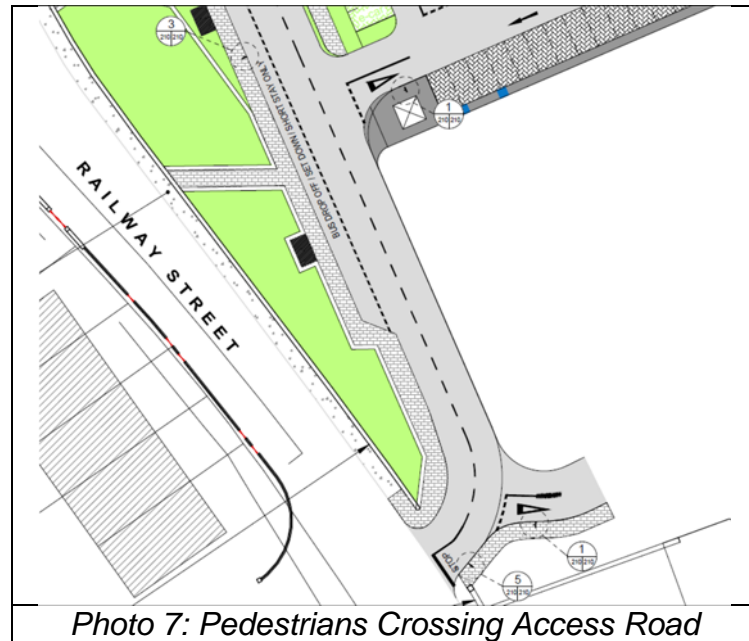
Upon entering either the middle or the southern pedestrian access to the development from Railway Street, a pedestrian crossing is not shown to be provided for pedestrians wishing to cross the access road at the Bus Drop-off in order to access the Public Transport Carpark or the houses in the southern end of the development. A lack of an adequate pedestrian crossing along the pedestrian desire lines may contribute to a pedestrian injury at this location.

Provide an adequate pedestrian crossing along the pedestrian desire lines to accommodate pedestrians accessing the Public Transport Carpark and the houses in the southern end of the development from the middle and the southern pedestrian accesses to the development.
