Laois County Council

Housing Development, Abbeyleix
Road, Portlaoise

Stage 1 Road Safety Audit

Document Ref:	P22-082-RSA-PD-RP-001
----------------------	------------------------------

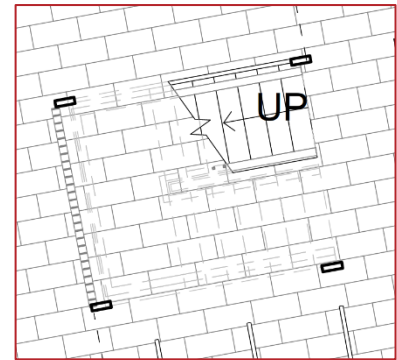
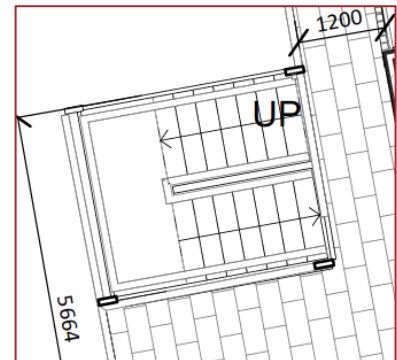
Location: Drawing 1933-OBFA-DR-A-2003

Summary: Tactile paving has not been indicated at the top and bottom of steps within the proposed development.

Tactile paving has not been indicated at the top and bottom of the steps within the proposed development. This may lead to a visually impaired pedestrian being insufficiently aware of the hazard and continuing towards the steps without due care and attention, resulting in trips and falls at the bottom of the steps, and personal injuries, or falls from a height at the top of the steps, and serious injuries.

Corduroy tactile paving should be provided at the top and bottom of the steps within the development.

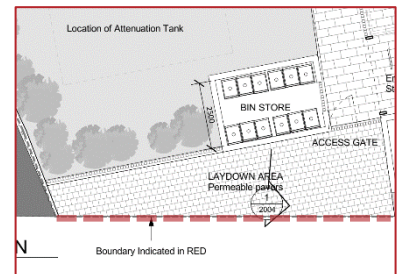
Location: Drawing 1933-OBFA-DR-A-2003

Summary: Visually impaired pedestrians may be unable to differentiate between the laydown area and adjacent Old Abbeyleix Road carriageway.

A laydown area with a surface composed of permeable pavers has been indicated at the western boundary of the proposed development adjacent the Old Abbeyleix Road. Visually impaired pedestrians exiting the development at this location may be unable to differentiate between the laydown area and the adjacent Old Abbeyleix Road carriageway. This could lead to a visually impaired pedestrian inadvertently entering the Old Abbeyleix Road carriageway where there is an increased risk of being struck by a vehicle

Tactile paving, or a similar warning strip, should be provided along the interface between the laydown area and the Old Abbeyleix Road carriageway.

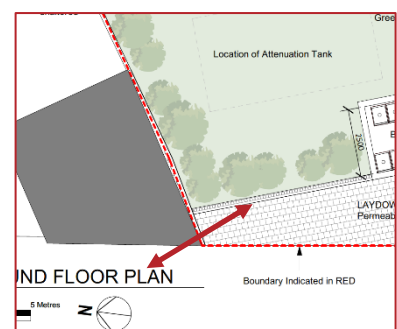
Location: Drawing 1933-OBFA-DR-A-2003

Summary: The adjacent building to the north of the development may restrict inter-visibility between a driver on the Old Abbeyleix Road and a pedestrian exiting the laydown area.

There is an existing building located to the north of the proposed development which borders the northern end of the laydown area at the development's western boundary. The building may block inter-visibility between a southbound driver on the Old Abbeyleix Road and a pedestrian exiting the laydown area resulting in a pedestrian exiting into the path of an oncoming driver who may have insufficient time to react resulting in an increased risk of vehicle-pedestrian collisions.

Provide landscaping within the laydown area adjacent the existing building to create a buffer zone, which will have the effect of maximising inter-visibility between drivers and pedestrians.

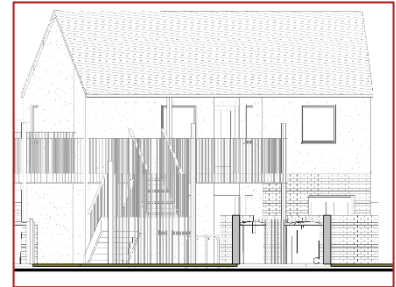
Location: Drawing 1933-OBFA-DR-A-2004

Summary: The vertical clearance beneath the first floor walkway and steps is unclear and, if too low, may present a hazard to pedestrians and cyclists.

A walkway has been indicated at first floor level which is accessed by steps and overhangs the ground floor level within the development. The vertical clearance between the walkway/steps and the surface has not been indicated and there is a risk that, if too low, the overhang of the walkway or corner of the steps may present a hazard to vulnerable road users, particularly cyclists, resulting in them striking the overhang/steps and suffering personal injuries. This would be a particular concern during the hours of darkness.

Ensure the vertical clearance between ground level and the overhang/steps is a minimum of 2.5m to accommodate cyclists.

Where this clearance cannot be achieved (e.g. where the steps rise or at landing areas on the steps) measures should be provided to clearly highlight the hazard to pedestrians and cyclists which should be sufficiently visible during the hours of darkness.

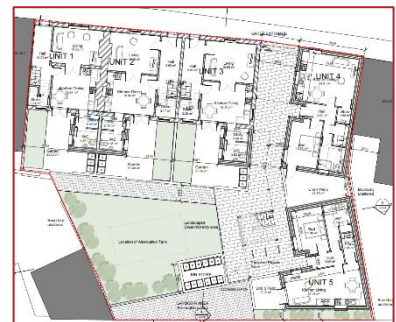
Location: Drawing 1933-OBFA-DR-A-2003

Summary: It is unclear if the development will be sufficiently drained.

Information regarding the proposed drainage measures within the development has not been provided to the Audit Team with the exception of an attenuation pond within the development. It is therefore unclear if the pavement surface within the development will sufficiently shed surface water. If sufficient drainage measures are not provided there is a risk of ponding within the development resulting in a risk of slips and falls during wet and icy weather.

Ensure the development sufficiently sheds surface water.

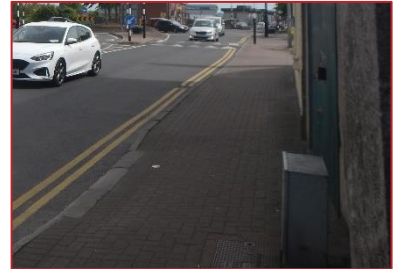
Location: Site visit observation

Summary: It is unclear if the existing dropped kerb at the existing vehicular access on the N80 is to be removed and, if retained, it may lead to visually impaired pedestrians being unable to detect the edge of the carriageway.

There is an existing dropped kerb within the footpath on the western side of the N80 at the existing vehicular access to the site of the proposed development. Vehicular access is not proposed to the development from the N80 resulting in the dropped kerb no longer being necessary. It is unclear if it is intended to remove the dropped kerb as part of the proposed development. If retained, it may lead to a visually impaired pedestrian on the footpath, or when exiting the development, being unable to detect the edge of the carriageway resulting in them inadvertently entering the N80 carriageway where there is an increased risk of being struck by a vehicle.

The dropped kerb should be replaced with a full height kerb, and the footway raised to match the full height kerb line.

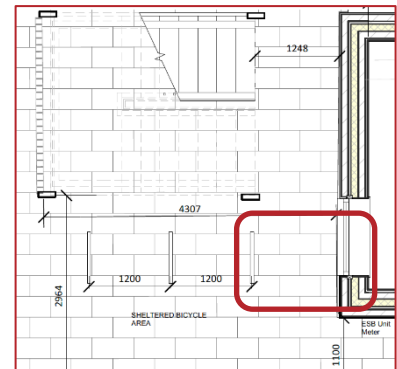
4.1 Bicycle parking stands have been indicated within the development beneath the first floor walkway adjacent Unit 5. The distance between the southernmost bicycle stand and the boundary of Unit 5 has not been indicated, however it is assumed to be approximately 1.25m as indicated between the stairwell and the Unit 5 boundary to the east.

Should this bicycle stand be occupied the effective width of the pedestrian route may be further restricted and may not be sufficiently wide enough to accommodate mobility impaired pedestrians, particularly wheelchair users, thus restricting access to Unit 5. Ensure there is sufficient effective width at this location for a mobility impaired pedestrian to pass when the bicycle stand is occupied.
