Housing Development, Abbeyleix
Road, Portlaoise

Stage 1 Road Safety Audit

Document Ref:	P22-082-RSA-PD-RP-001
----------------------	------------------------------

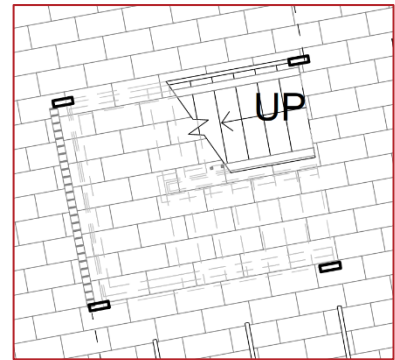
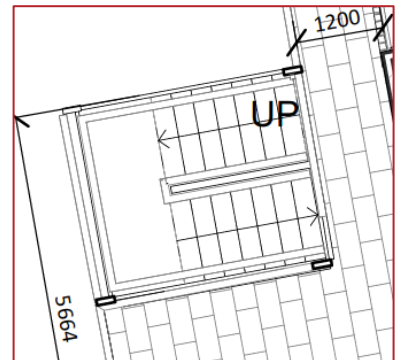
3.1 Problem

Summary: Tactile paving has not been indicated at the top and bottom of steps within the proposed development.

Tactile paving has not been indicated at the top and bottom of the steps within the proposed development. This may lead to a visually impaired pedestrian being insufficiently aware of the hazard and continuing towards the steps without due care and attention, resulting in trips and falls at the bottom of the steps, and personal injuries, or falls from a height at the top of the steps, and serious injuries.

Corduroy tactile paving should be provided at the top and bottom of the steps within the development.

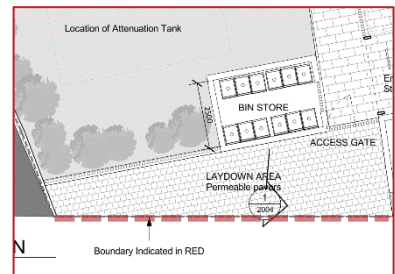
3.2 Problem

Summary: Visually impaired pedestrians may be unable to differentiate between the laydown area and adjacent Old Abbeyleix Road carriageway.

A laydown area with a surface composed of permeable pavers has been indicated at the western boundary of the proposed development adjacent the Old Abbeyleix Road. Visually impaired pedestrians exiting the development at this location may be unable to differentiate between the laydown area and the adjacent Old Abbeyleix Road carriageway. This could lead to a visually impaired pedestrian inadvertently entering the Old Abbeyleix Road carriageway where there is an increased risk of being struck by a vehicle

Tactile paving, or a similar warning strip, should be provided along the interface between the laydown area and the Old Abbeyleix Road carriageway.

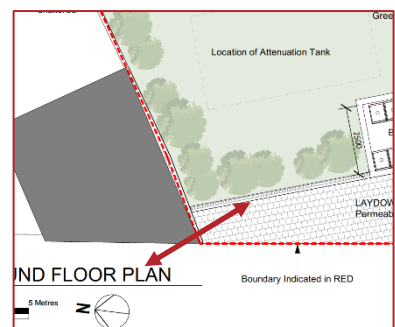
3.3 Problem

Summary: The adjacent building to the north of the development may restrict inter-visibility between a driver on the Old Abbeyleix Road and a pedestrian exiting the laydown area.

There is an existing building located to the north of the proposed development which borders the northern end of the laydown area at the development's western boundary. The building may block inter-visibility between a southbound driver on the Old Abbeyleix Road and a pedestrian exiting the laydown area resulting in a pedestrian exiting into the path of an oncoming driver who may have insufficient time to react resulting in an increased risk of vehicle-pedestrian collisions.

Provide landscaping within the laydown area adjacent the existing building to create a buffer zone, which will have the effect of maximising inter-visibility between drivers and pedestrians.

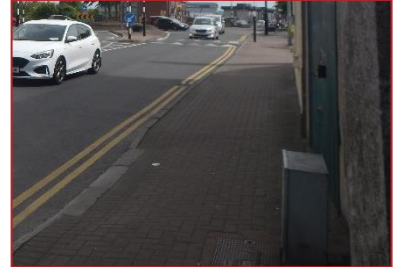
3.6 Problem

Summary: It is unclear if the existing dropped kerb at the existing vehicular access on the N80 is to be removed and, if retained, it may lead to visually impaired pedestrians being unable to detect the edge of the carriageway.

There is an existing dropped kerb within the footpath on the western side of the N80 at the existing vehicular access to the site of the proposed development. Vehicular access is not proposed to the development from the N80 resulting in the dropped kerb no longer being necessary. It is unclear if it is intended to remove the dropped kerb as part of the proposed development. If retained, it may lead to a visually impaired pedestrian on the footpath, or when exiting the development, being unable to detect the edge of the carriageway resulting in them inadvertently entering the N80 carriageway where there is an increased risk of being struck by a vehicle.

The dropped kerb should be replaced with a full height kerb, and the footway raised to match the full height kerb line.

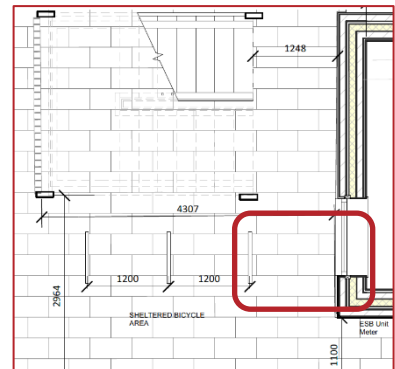
4.1 Bicycle parking stands have been indicated within the development beneath the first floor walkway adjacent Unit 5. The distance between the southernmost bicycle stand and the boundary of Unit 5 has not been indicated, however it is assumed to be approximately 1.25m as indicated between the stairwell and the Unit 5 boundary to the east.

Should this bicycle stand be occupied the effective width of the pedestrian route may be further restricted and may not be sufficiently wide enough to accommodate mobility impaired pedestrians, particularly wheelchair users, thus restricting access to Unit 5. Ensure there is sufficient effective width at this location for a mobility impaired pedestrian to pass when the bicycle stand is occupied.
