Digital Hub Borris-In-Ossory Courthouse

Design Statement and Architectural Impact Assessment

July 2023

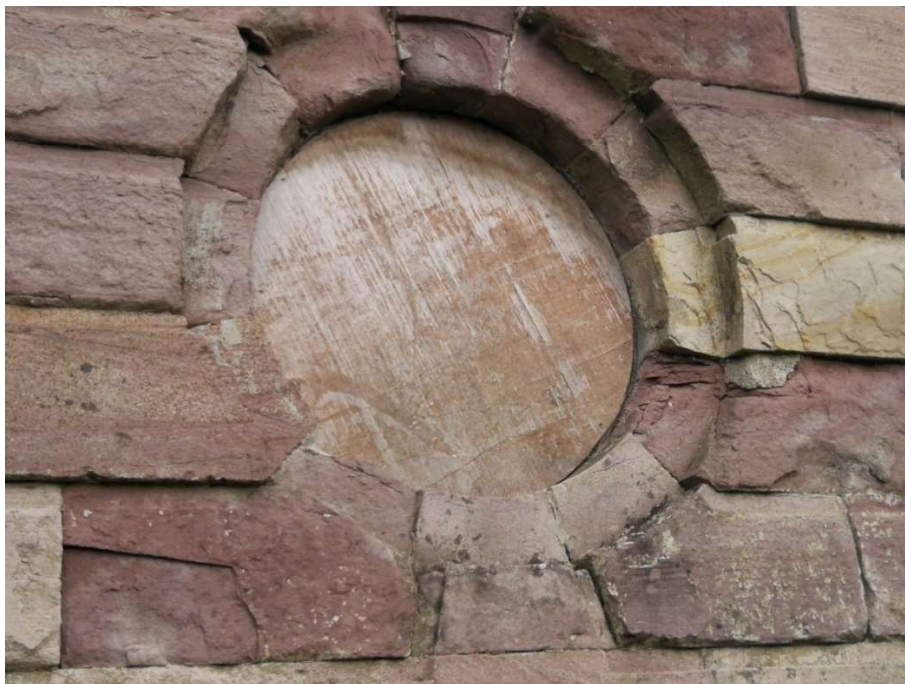
Figure 5 – Typical sandstone condition; spalling, cracked, falling away

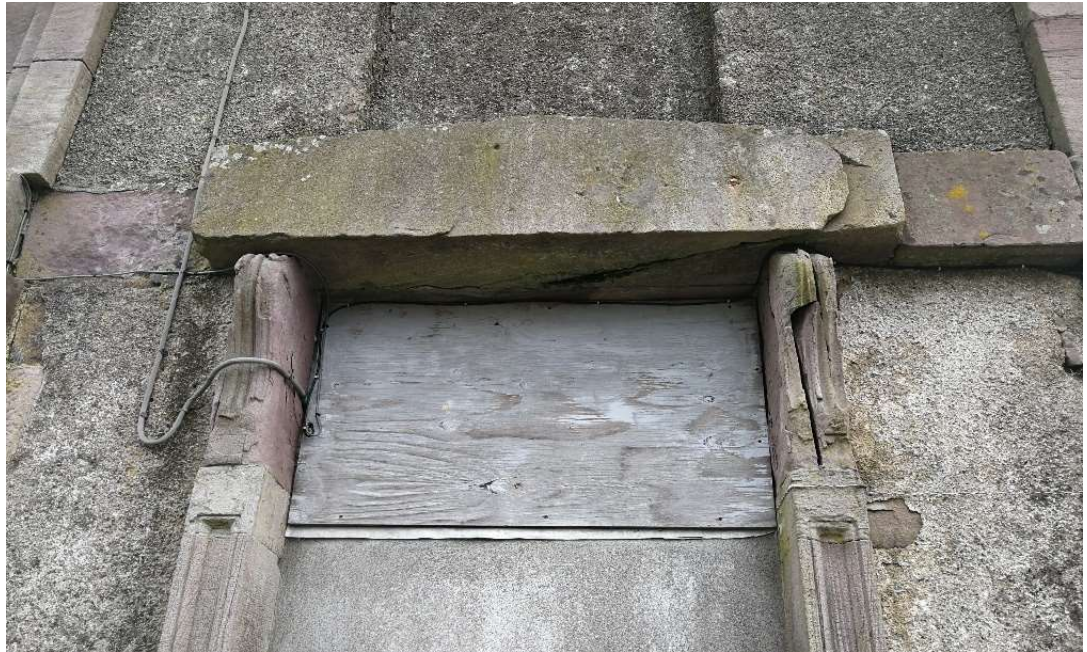
Figure 6 – Cracked lintel over door surround, west elevation

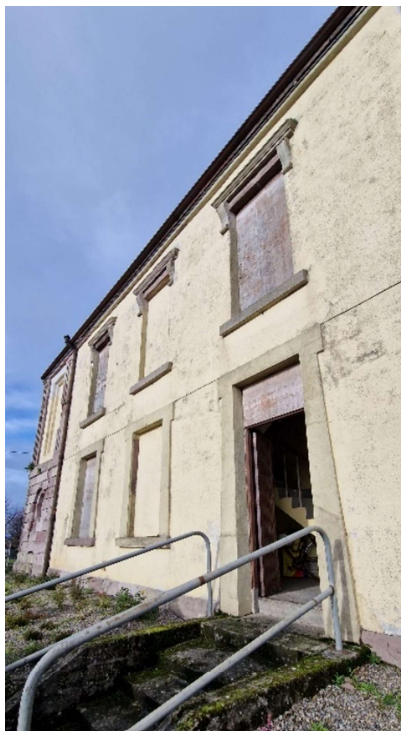
There are granite sills on the north, south and east elevations. There is a roughcast rendered finish to the north, east and west elevation, with a smooth rendered finish to the south elevation. Some of the roughcast render is spalling, particularly on the west and east elevations.

Figure 7 – Smooth rendered south elevation

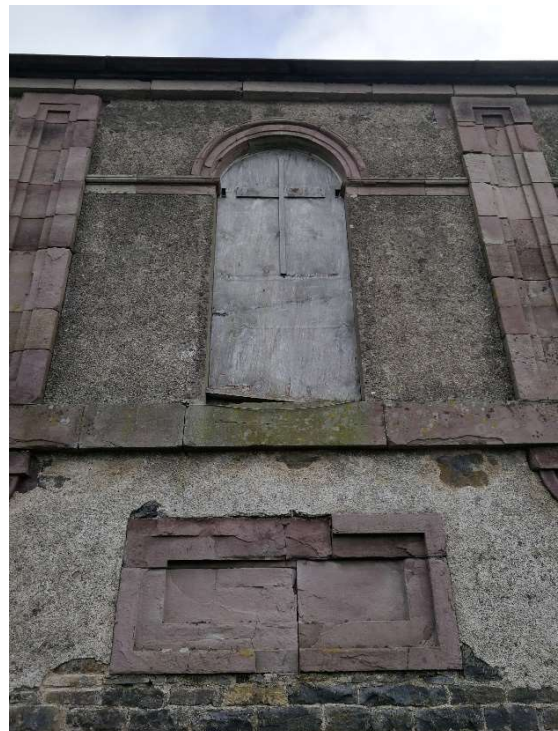
Figure 8 - Decaying sandstone, south elevation

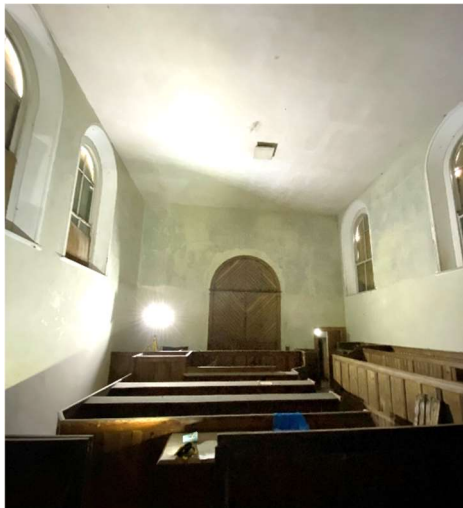
The courtroom floor is formed of timber joists and floorboards, with concrete infill between the joists. There is built-in joinery in the courtroom including seats, raised platforms, desks and screens. There is active woodworm evident throughout the floor and the joinery in the courtroom. The floorboards are soft in places and are generally in poor condition.

Figure 13 – Courtroom looking south

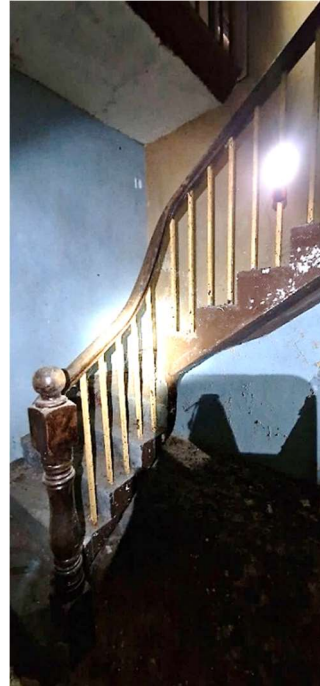
Figure 16 – Stairs in north wing with bottom steps replaced with concrete

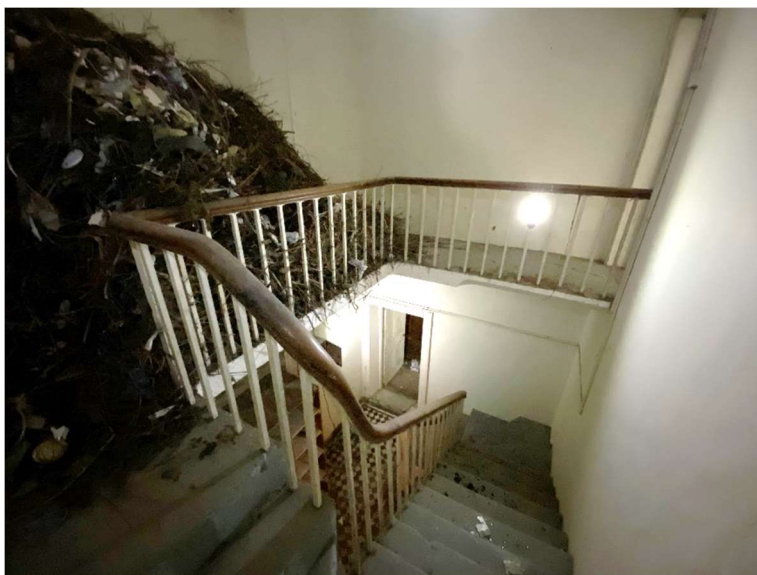
Figure 17 – Large birds' nest on upper landing of stairs in south wing

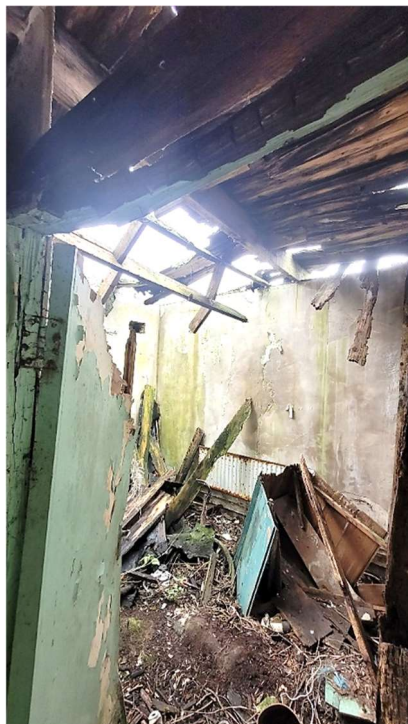
Figure 18 – Eastern extension to north wing in poor condition

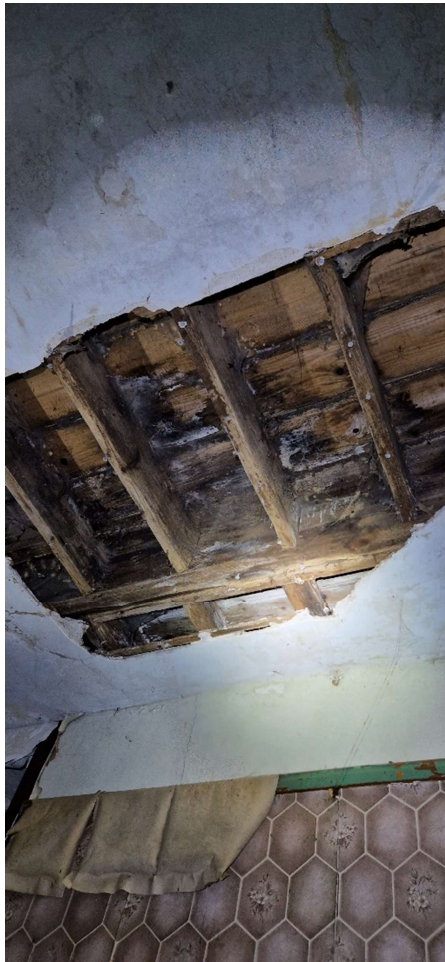
Figure 20 – Ceiling finishes missing in room GF-3

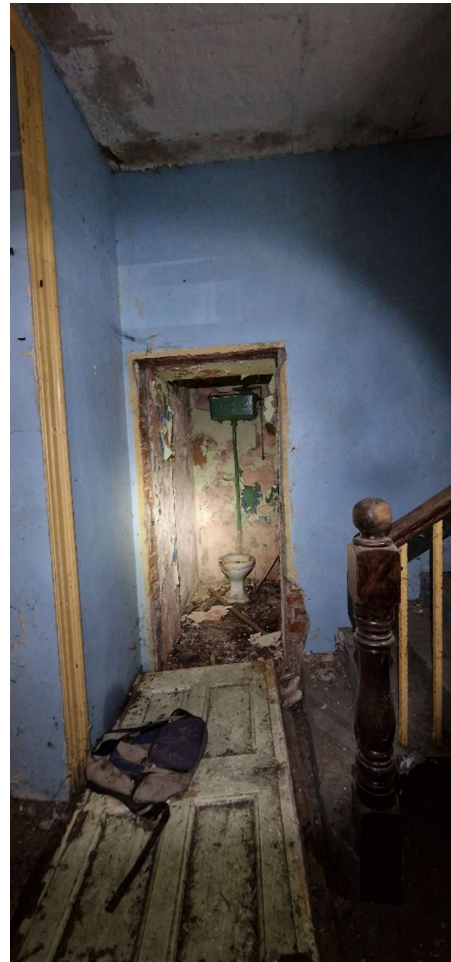
The final room at ground floor in the north wing (GF-1) is a bathroom outshot to the northwest corner, which is in poor condition. The timber door surround has fallen forward into the stairwell, pulling some of the brick reveals with it. As viewed from the outside, the flat concrete roof has a collapsing water tank on top of it, with a downpipe from the gutter at roof level discharging into it. There is also a build-up of vegetation growing from this flat roof area.

Figure 21 – Bathroom outshot (GF-1) door fallen into stairwell, north wing

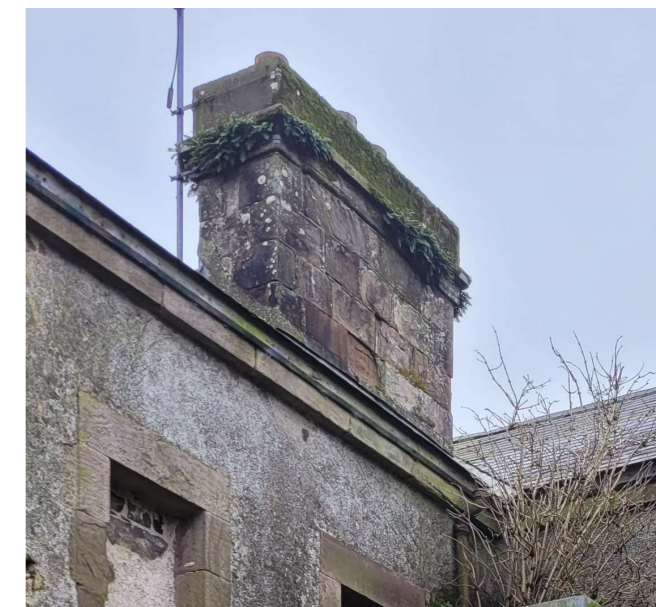
Chimney in poor condition

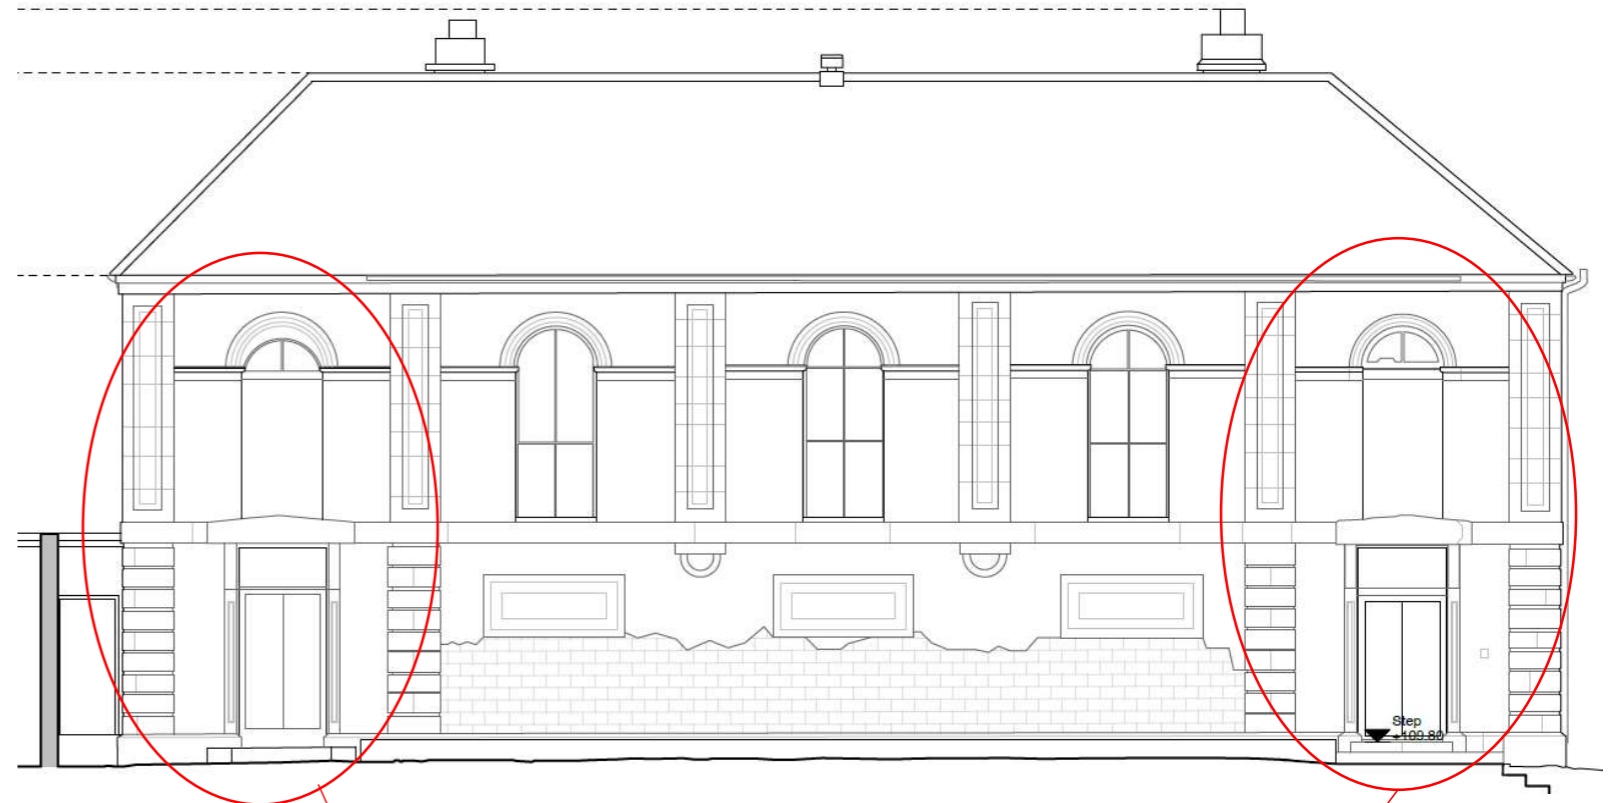
West elevation

Sandstone elements on all elevations in poor condition, requires significant replacement and repair. Includes but not limited to; eaves course, string course, wall cladding panels, lintels, decorative elements, quoins, chimneys.

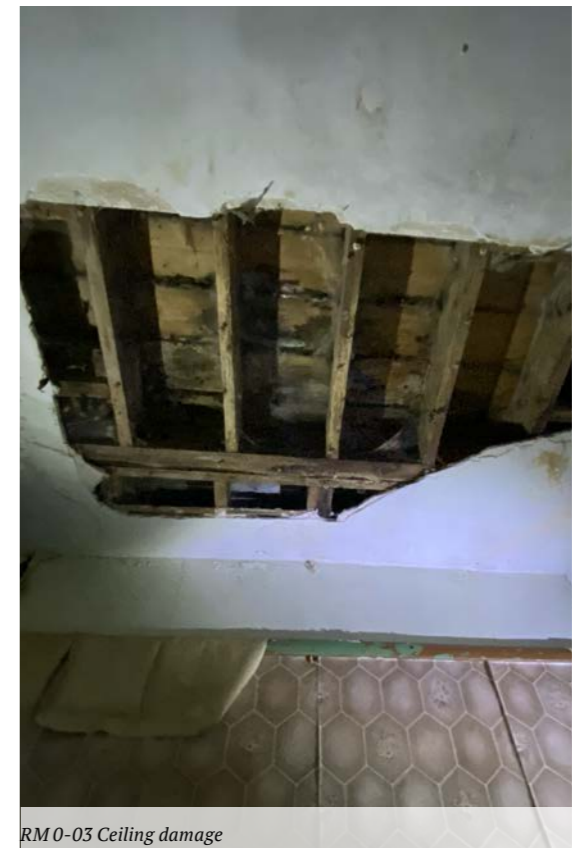
RM 0-03 Ceiling damage
