Client	HHC
Title	Borris In Ossory Courthouse

Surveyor	N.Fuentes	N.F.	Eng. check	-	-
Drawn	C.Dous	C.D.	Coordination	-	-
Dwg check	K.Sheehan	K.S.	Approved	J.Markham	J.M.
Scale at A0	1:200	Status	Complete	Rev	02
Drawing Number	PUM-11273-U-DR-0001-02

Title	Borris In Ossory Courthouse
-------	-----------------------------

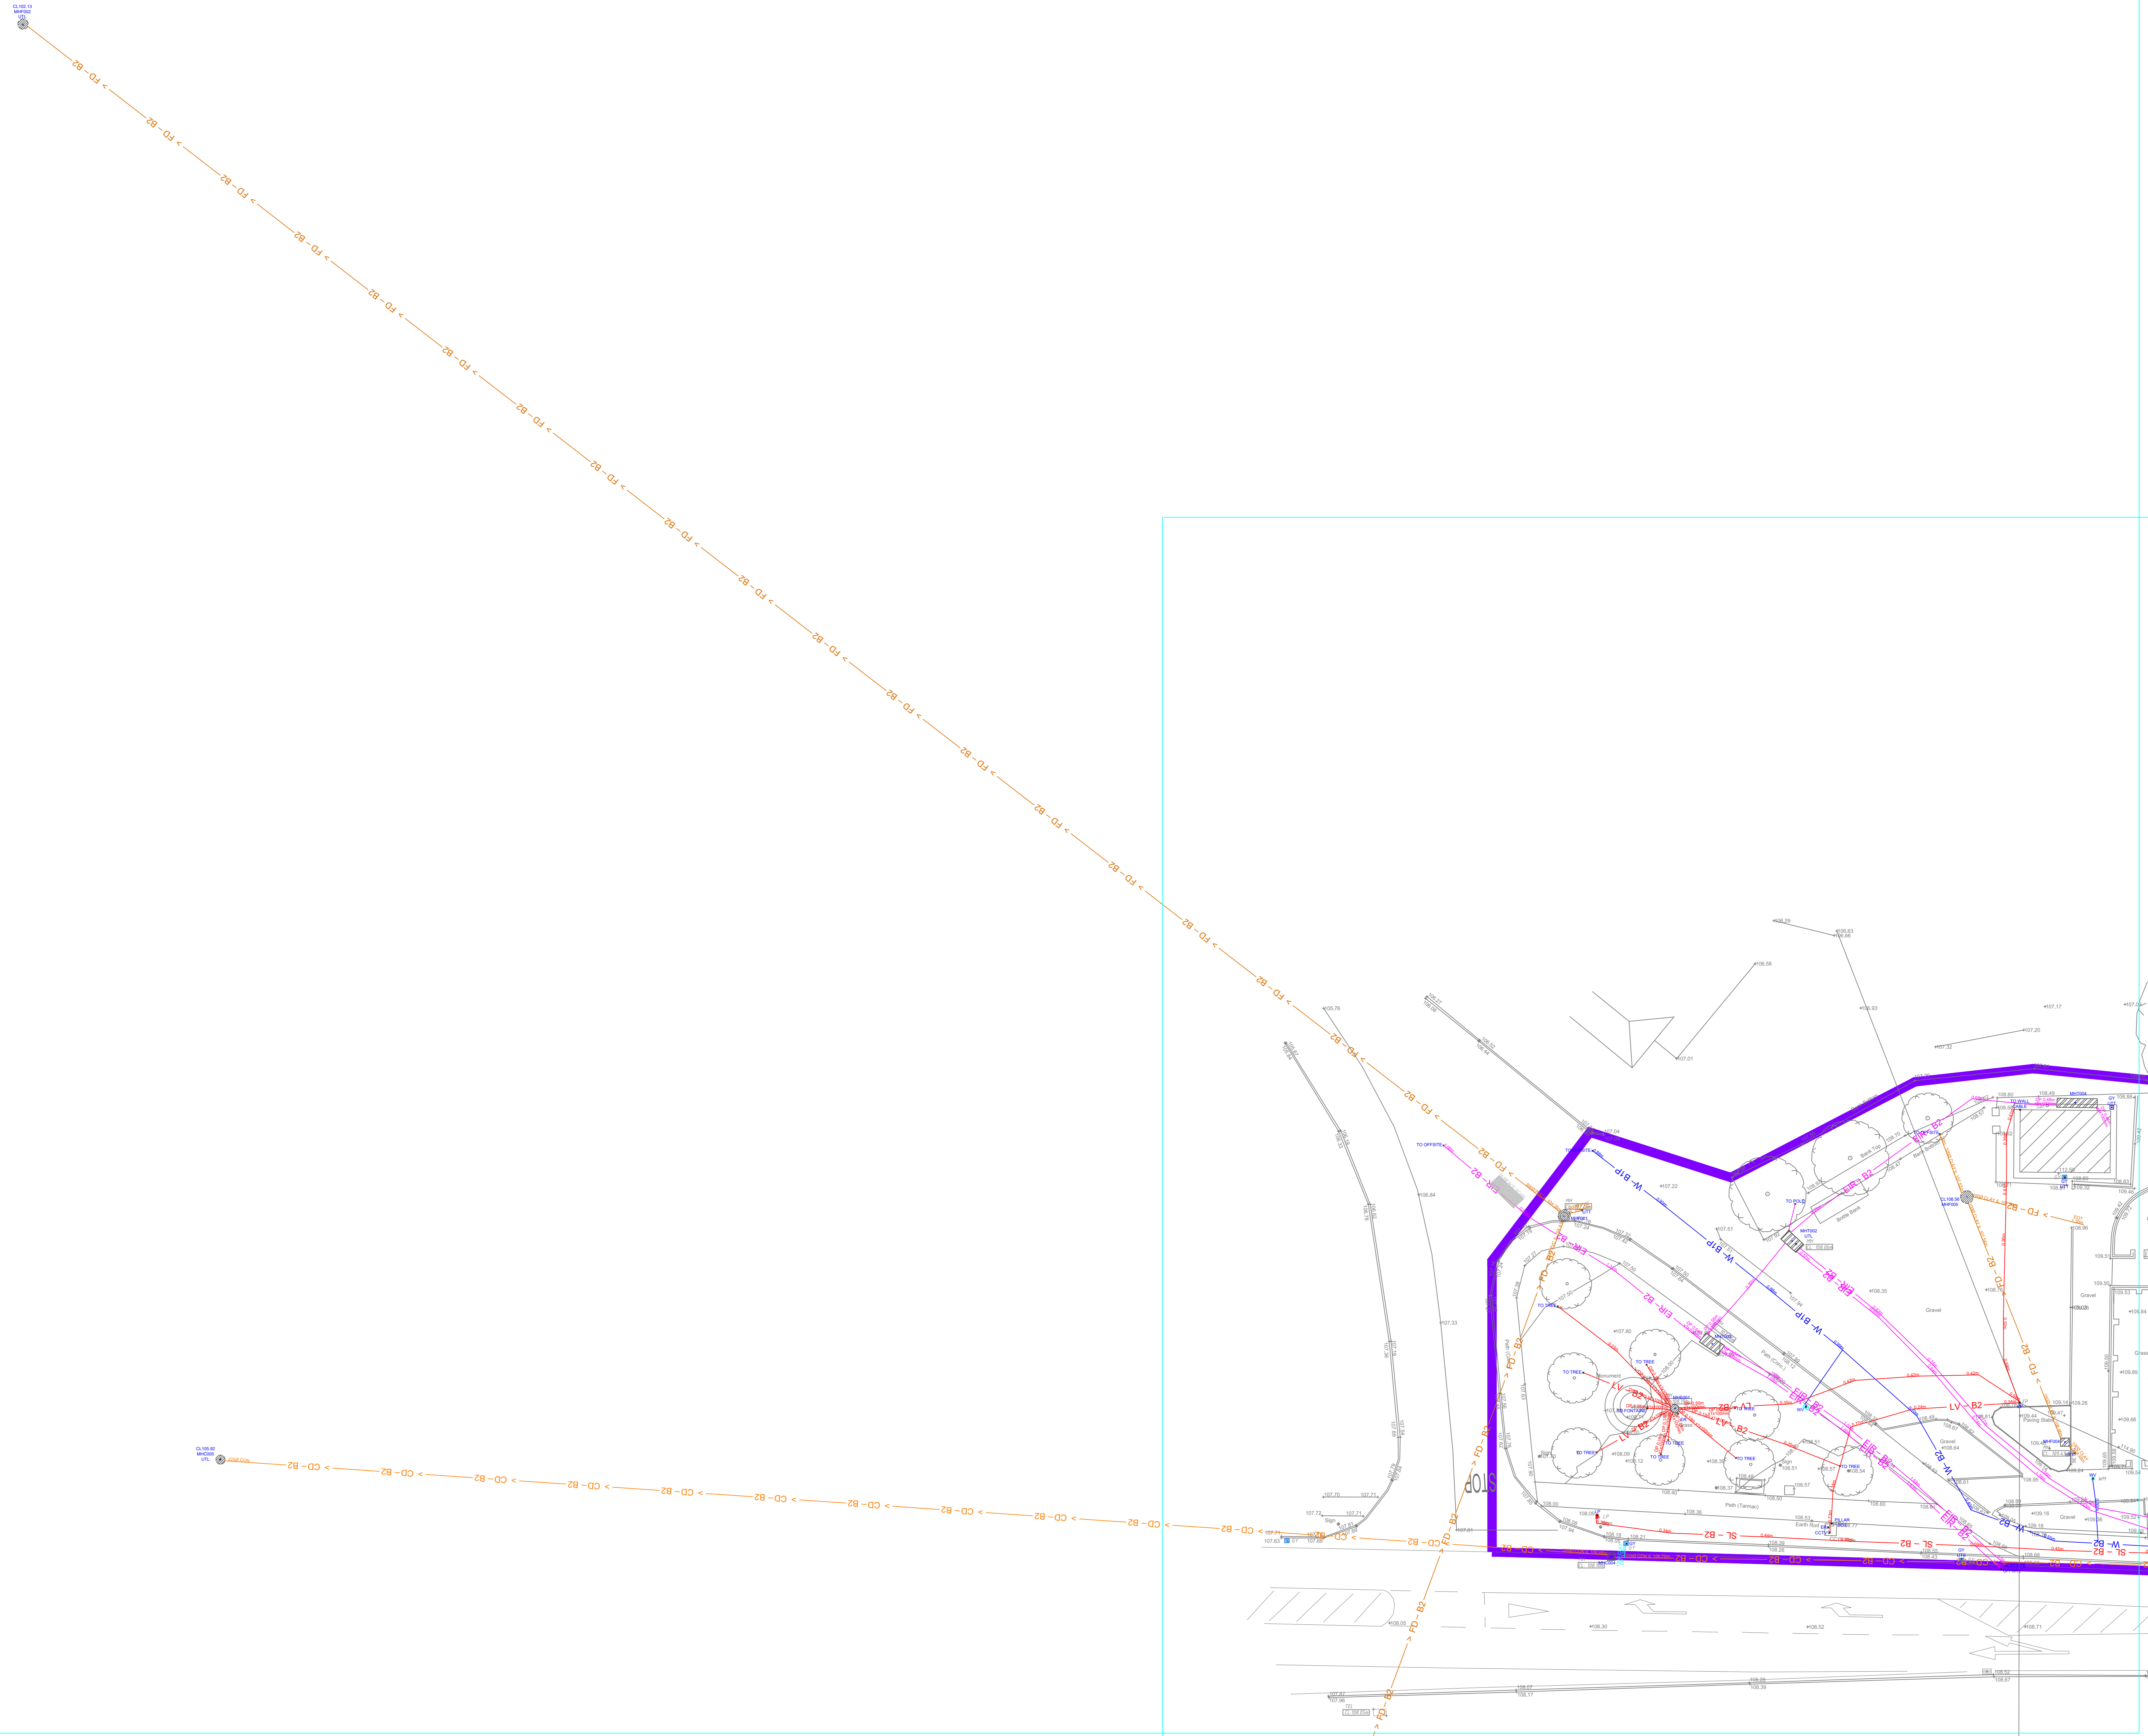
The data presented in this drawing has been collected using a combination of the following: consultation of utility asset information, visual survey & inspection of manholes and inspection chambers, electromagnetic location techniques, ground penetrating radar, and, where applicable, trial hole excavations. These techniques have been employed in accordance with the BS PAS 238 Specification for Underground Utility Detection, Verification and Location using the search methodologies indicated below and described in the accompanying report. This drawing should be used in conjunction with the accompanying report which details the limitations of these techniques and any remedial factors encountered during this survey.

Unless otherwise stated, all utilities shown on this plan have been surveyed using approved detectors and the connections between inspection chambers, if unable to be detected, are generally assumed to be direct unless there are some indications to the contrary. The detection confidence for each utility segment is indicated in line with the PAS 238 scheme outlined below. Information depicted as CL-C or CL-D cannot be guaranteed as it is based on historic utility records which can be inaccurate and incomplete.
