Housing Development,  
Mooreville, Rathdowney, Co Laois

Stage 1 Road Safety Audit

<b>Document Ref:</b>	<b>P20-060-RSA-PD-RP-001</b>
----------------------	------------------------------

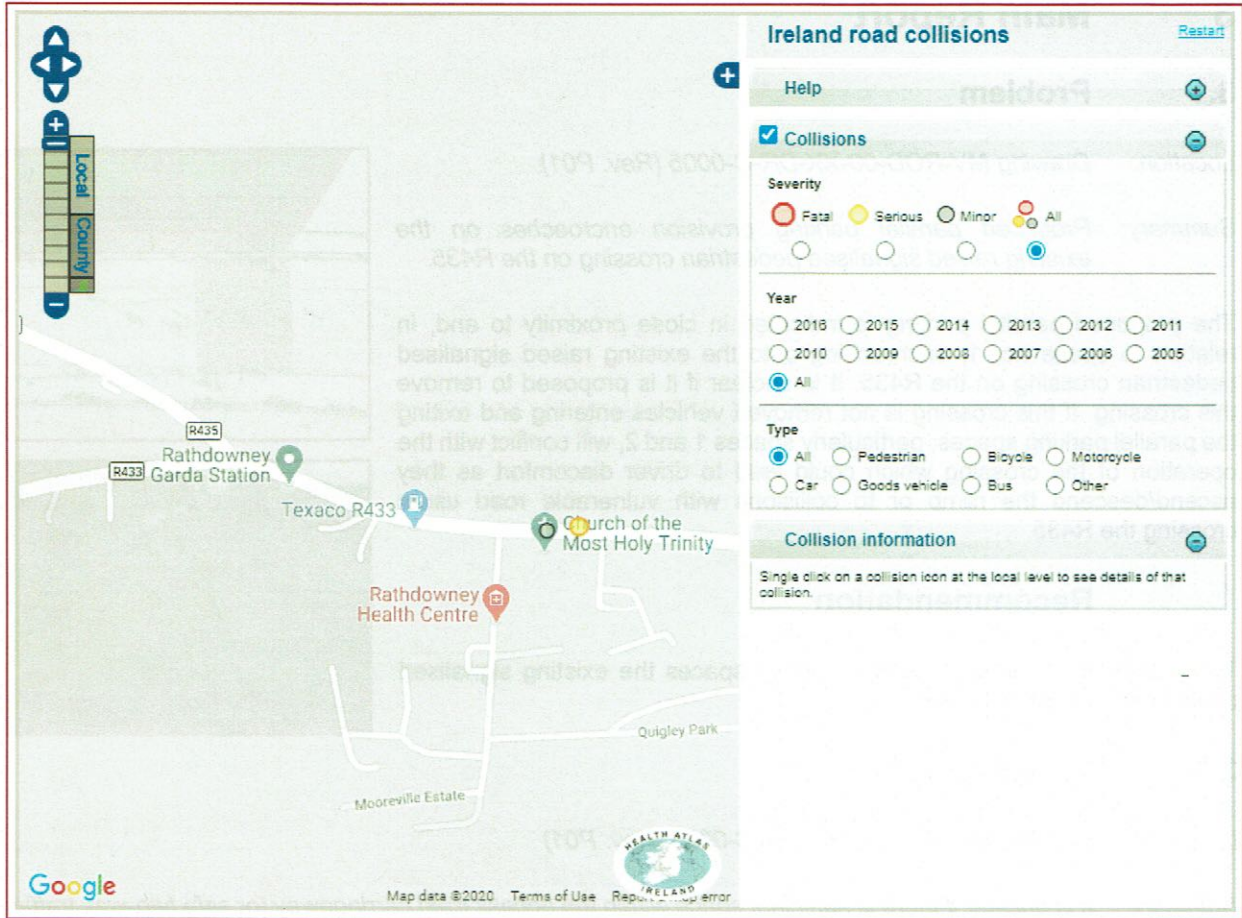
FIGURE 2-2: COLLISIONS RECORDED IN THE VICINITY OF THE SITE OF THE PROPOSED RESIDENTIAL DEVELOPMENT (SOURCE: ROAD SAFETY AUTHORITY)

Two collisions were recorded on the R435 in the vicinity of the site of the proposed development. A head-on collision involving a car resulting in Minor Injury occurred on the R435 occurred in 2014 between 10am and 4pm while a Serious Injury collision involving a car and a pedestrian occurred in 2006 between 7pm and 11pm.

No pattern in collision occurrence has been identified in the vicinity of the site of the proposed development.
