Digital Hub Borris-In-Ossory Courthouse

Design Statement and Architectural Impact Assessment

July 2023

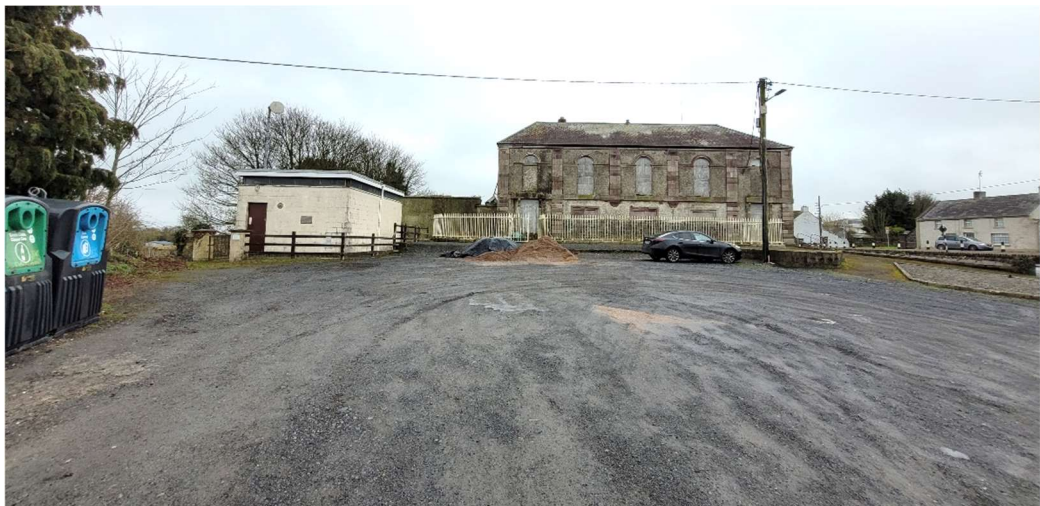
Figure 1: Borris-in-Ossory courthouse with Eircom interchange building to left hand side (north) and forecourt in foreground.

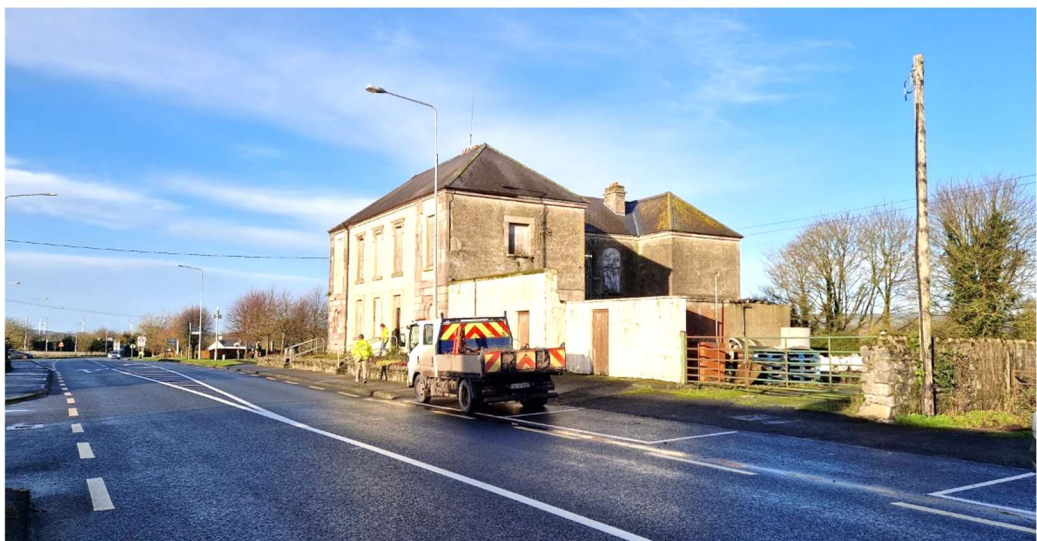
Figure 3: East elevation of courthouse with stored materials visible in foreground

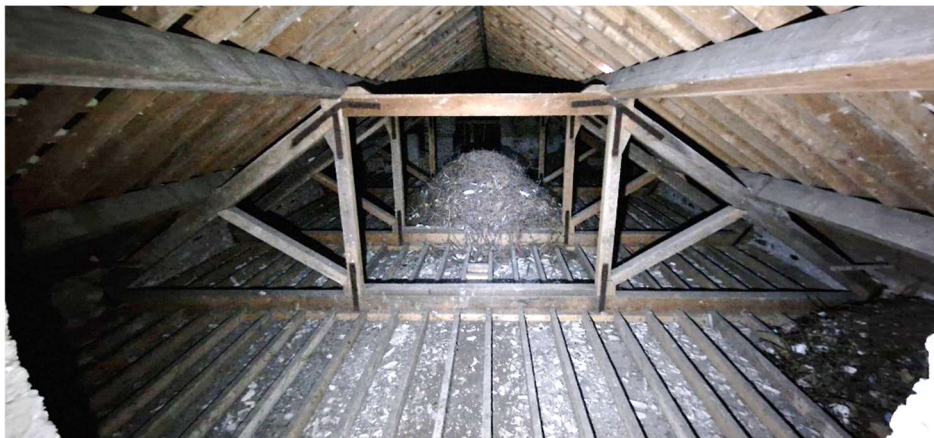
Figure 9 – Queen post trussed roof over courtroom

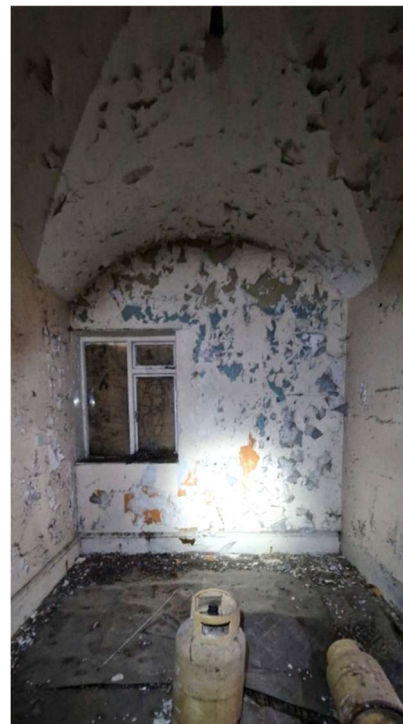
Figure 19 – Room GF-4 in north wing
