Lead Based Paint Inspection Report

Site Address	Old Courthouse Borris-in-Ossory Co. Laois
Site Location

Client	Name: Laois County Council Áras an Chontae JFL Avenue Portlaoise R32 EHP9 Contact: Ken Morley Instructing Party: Howley Hayes Architects, Patrick Tyrrell
Survey Dates	21/02/23
Issue Date	22/02/23
Surveyor(s)	John Kelleher, About Safety Ltd.

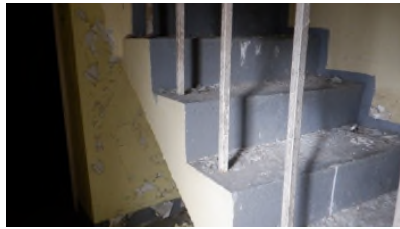
Sample Ref No.	Building/ Area	Location or Functional Space	Sample point	Component	Substrate (timber/ metal/ other)	Condition	Results (mg/cm ²)	Depth index	Photo
9.	Old Courthouse	East Wing Room 0.15	Stairway	Paint	Stone	Intact	<LOD	1.0

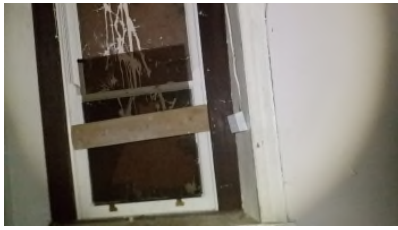
Sample Ref No.	Building/ Area	Location or Functional Space	Sample point	Component	Substrate (timber/ metal/ other)	Condition	Results (mg/cm ²)	Depth index	Photo
29.	Old Courthouse	East Wing Room 1.08	Door	Paint	Timber	Intact	<LOD	1.0	 
30.	Old Courthouse	East Wing Room 1.08	Window	Window frame	Timber	Intact	<LOD	1.0

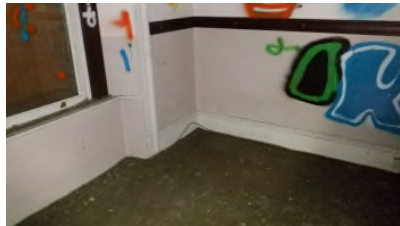
Sample Ref No.	Building/ Area	Location or Functional Space	Sample point	Component	Substrate (timber/ metal/ other)	Condition	Results (mg/cm ²)	Depth index	Photo
33.	Old Courthouse	East Wing Room 1.09	Skirting board	Paint	Timber	Intact	<LOD	1.2

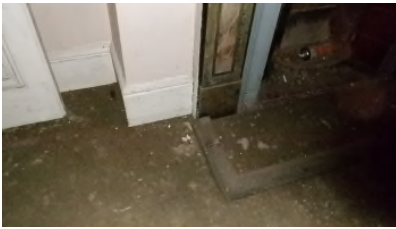
Sample Ref No.	Building/ Area	Location or Functional Space	Sample point	Component	Substrate (timber/ metal/ other)	Condition	Results (mg/cm ²)	Depth index	Photo
37.	Old Courthouse	East Wing Room 1.09	Skirting at fireplace	Paint	Timber	Intact	<LOD	1.0

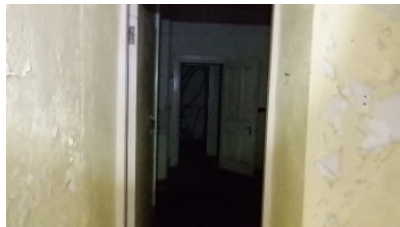
Sample Ref No.	Building/ Area	Location or Functional Space	Sample point	Component	Substrate (timber/ metal/ other)	Condition	Results (mg/cm ²)	Depth index	Photo
41.	Old Courthouse	East Wing Room 1.01	Door to Room 1.01	Architrave	Timber	Intact	<LOD	1.0	 
42.	Old Courthouse	East Wing Room 1.01	Door	Saddle	Timber	Intact	<LOD	1.0	 
43.	Old Courthouse	East ground floor Door to room 0.13	Door	Frame	Timber	Intact	<LOD	1.0

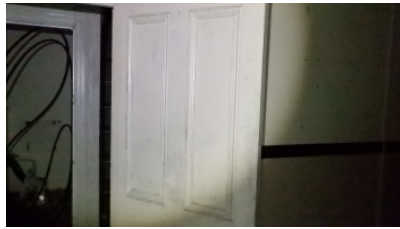
Sample Ref No.	Building/ Area	Location or Functional Space	Sample point	Component	Substrate (timber/ metal/ other)	Condition	Results (mg/cm ²)	Depth index	Photo
45.	Old Courthouse	East wing Ground floor Room 0.13	Door	Door	Timber	Intact	<LOD	1.0

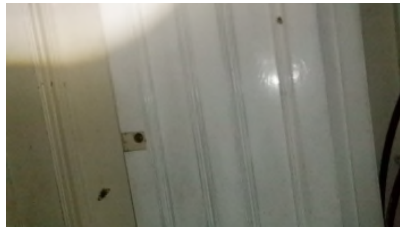
Sample Ref No.	Building/ Area	Location or Functional Space	Sample point	Component	Substrate (timber/ metal/ other)	Condition	Results (mg/cm ²)	Depth index	Photo
49.	Old Courthouse	East wing Ground floor Room 0.01	Door	Door	Timber	Intact	<LOD	1.0

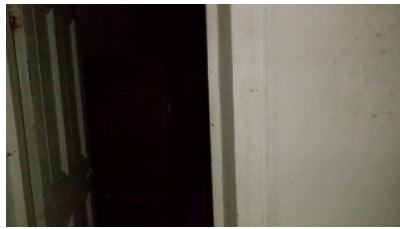
Sample Ref No.	Building/ Area	Location or Functional Space	Sample point	Component	Substrate (timber/ metal/ other)	Condition	Results (mg/cm ²)	Depth index	Photo
53.	Old Courthouse	East wing Ground floor Room 0.02	Stairway	Spindle	Metal	Intact	<LOD	1.0	 
54.	Old Courthouse	Courtroom Door from 0.02	Door	Architrave	Timber	Intact	<LOD	1.0

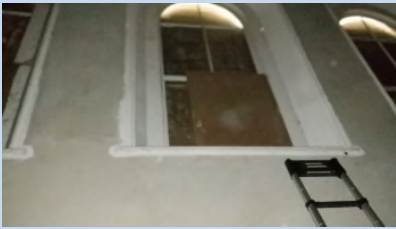
Sample Ref No.	Building/ Area	Location or Functional Space	Sample point	Component	Substrate (timber/ metal/ other)	Condition	Results (mg/cm ²)	Depth index	Photo
61.	Old Courthouse	Courtroom	Back windows	Window frames	Timber	Intact	3.18	3.6

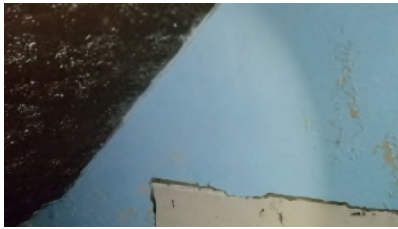
Sample Ref No.	Building/ Area	Location or Functional Space	Sample point	Component	Substrate (timber/ metal/ other)	Condition	Results (mg/cm ²)	Depth index	Photo
73.	Old Courthouse	West Wing Room 0.04	Wall	Paint	Plaster	Flaking	<LOD	1.0

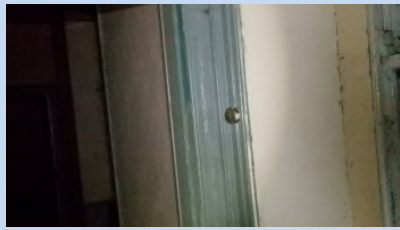
Sample Ref No.	Building/ Area	Location or Functional Space	Sample point	Component	Substrate (timber/ metal/ other)	Condition	Results (mg/cm ²)	Depth index	Photo
89.	Old Courthouse	West Wing 1 st floor Room 1.04	Door	Door frame	Timber	Intact	<LOD	1.0	 
90.	Old Courthouse	West Wing 1 st floor Room 1.04	Door	Door	Timber	Intact	1.12	1.2	 
91.	Old Courthouse	West Wing 1 st floor Room 1.04	Door	Door	Timber	Intact	1.38	2.8

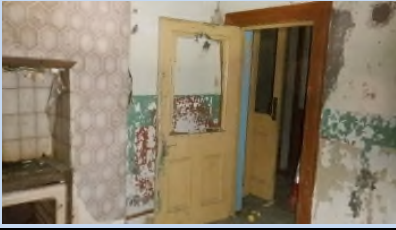
Sample Ref No.	Building/ Area	Location or Functional Space	Sample point	Component	Substrate (timber/ metal/ other)	Condition	Results (mg/cm ²)	Depth index	Photo
97.	Old Courthouse	West Wing 1 st floor Room 1.04	Floor	Skirting board	Timber	Flaking	1.1	1.4	 
98.	Old Courthouse	West Wing Ground floor kitchen Room 0.06	Door	Door	Timber	Flaking	1.71	1.7

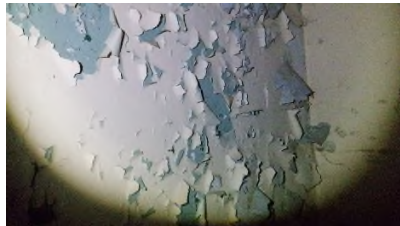
Sample Ref No.	Building/ Area	Location or Functional Space	Sample point	Component	Substrate (timber/ metal/ other)	Condition	Results (mg/cm ²)	Depth index	Photo
109.	Old Courthouse	West Wing Ground floor Room 0.07	Walls	Paint	Plaster	Flaking	<LOD	1.0

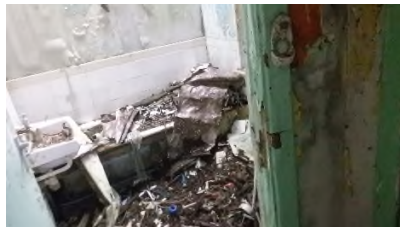
Sample Ref No.	Building/ Area	Location or Functional Space	Sample point	Component	Substrate (timber/ metal/ other)	Condition	Results (mg/cm ²)	Depth index	Photo
113.	Old Courthouse	West Wing Ground floor Room 0.10	Bathroom	Door	Timber	intact	<LOD	1.0
