Laois County Council

Housing Development, Abbeyleix
Road, Portlaoise

Stage 1 Road Safety Audit

Document Ref:	P22-082-RSA-PD-RP-001
----------------------	------------------------------

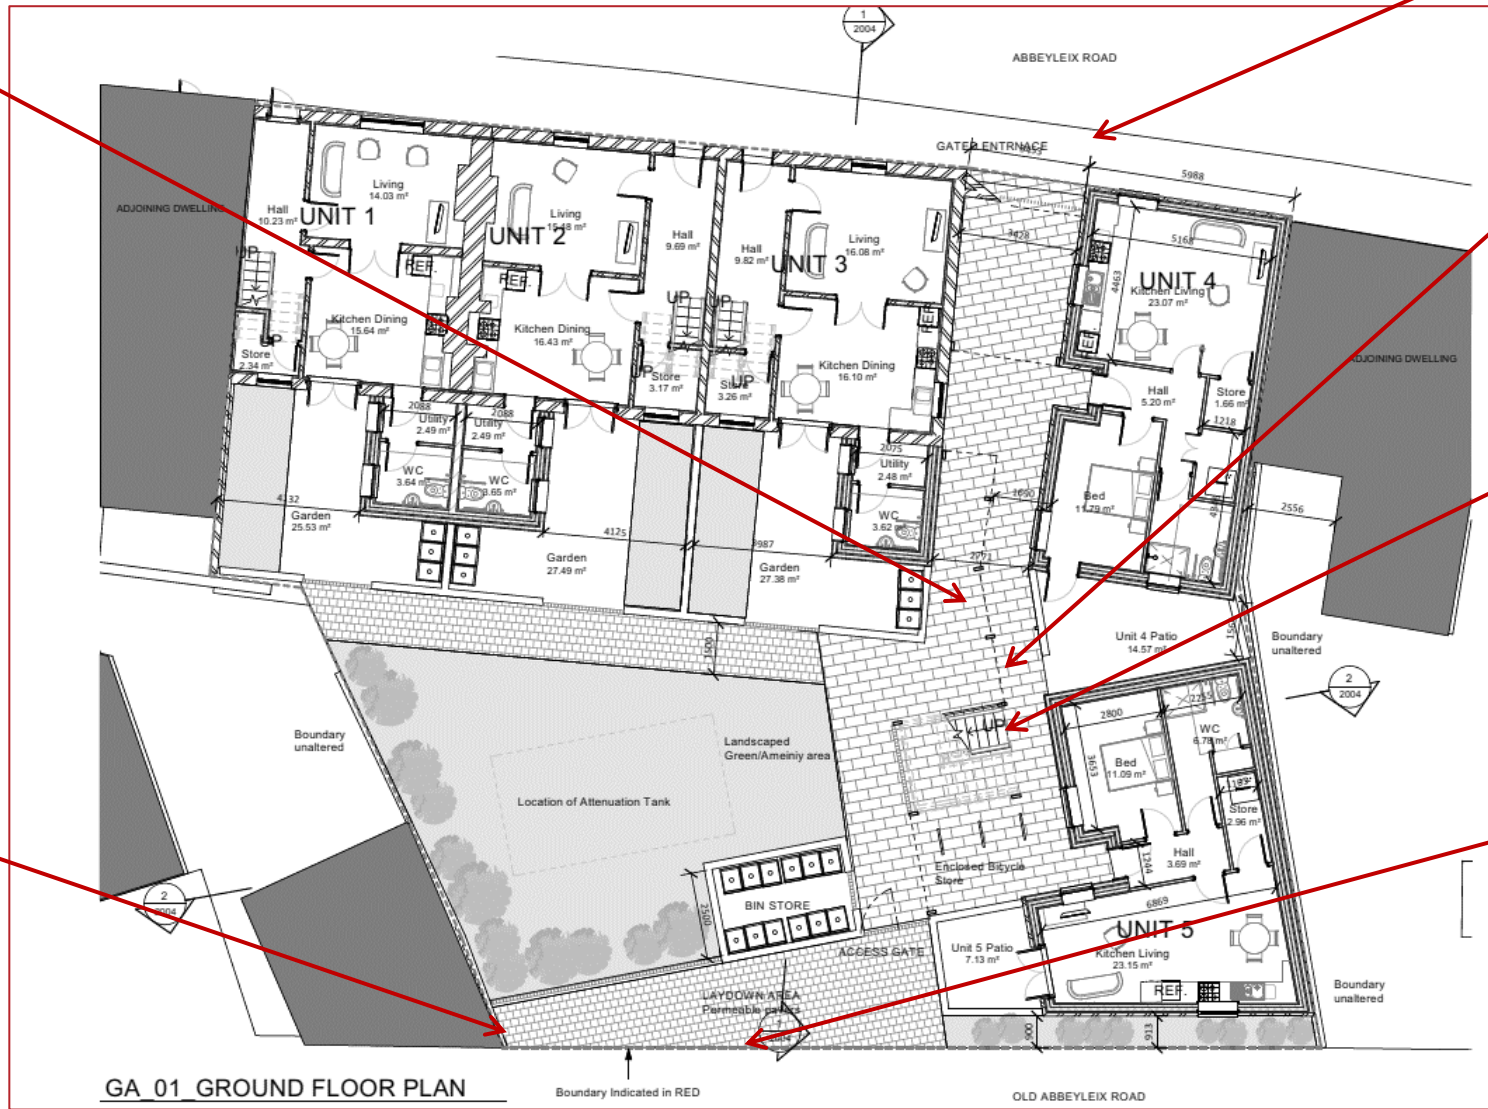
GA_01_GROUND FLOOR PLAN

Summary: Visually impaired pedestrians may be unable to differentiate between the laydown area and adjacent Old Abbeyleix Road carriageway.

A laydown area with a surface composed of permeable pavers has been indicated at the western boundary of the proposed development adjacent the Old Abbeyleix Road. Visually impaired pedestrians exiting the development at this location may be unable to differentiate between the laydown area and the adjacent Old Abbeyleix Road carriageway. This could lead to a visually impaired pedestrian inadvertently entering the Old Abbeyleix Road carriageway where there is an increased risk of being struck by a vehicle

Problem 3.3

Problem 3.2
