Project		Borris-in-Ossory Courthouse		Main Street, Borris-in-Ossory, Co. Laois	
Client		Laois County Council			
Drawing		West Elevation - Repairs			
Project Stage	Date	Scale	Project No.	Drawing No.	Revision
Stage 2	15/08/23	1:100@A3	0639	L-036	A

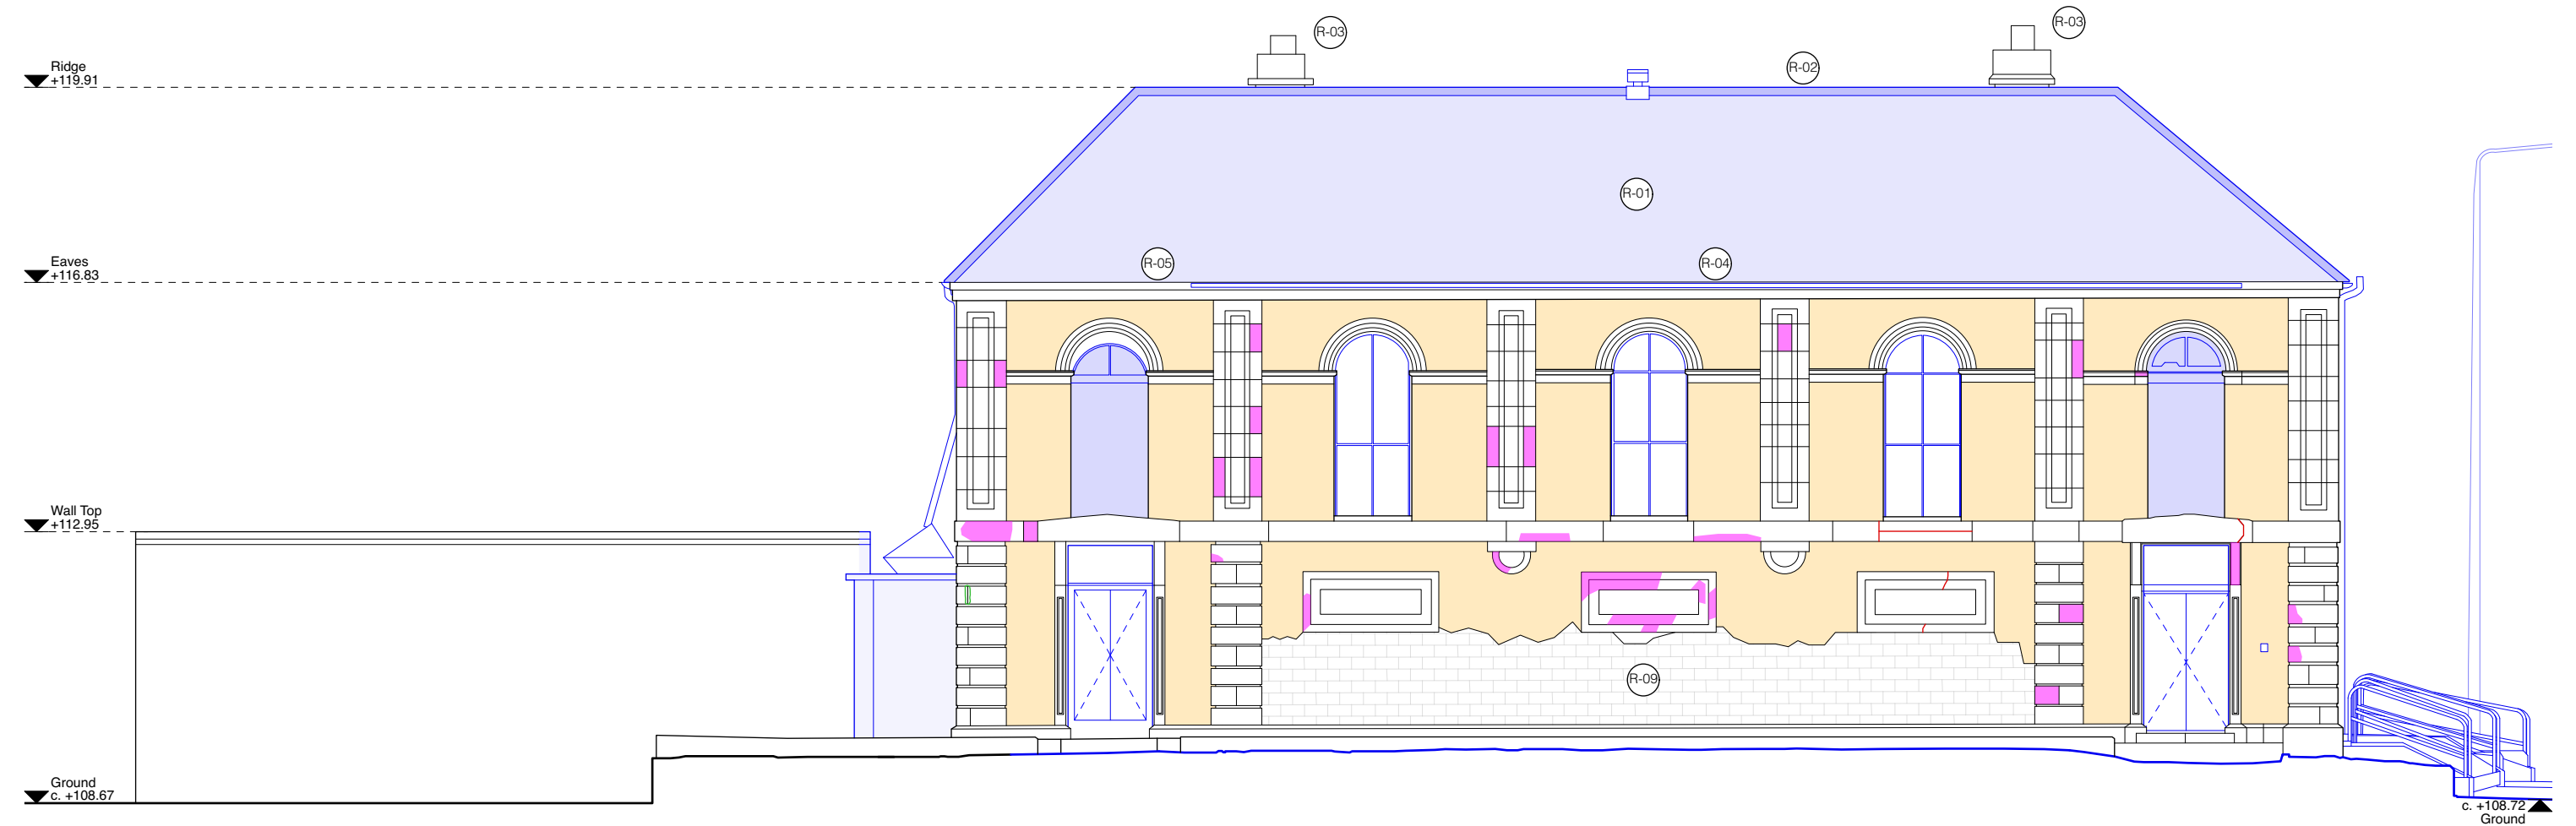
- R-01 Existing roof slates to be carefully stripped and set aside for reinstatement. Matching natural slate to be installed where new slate is required.
- R-02 Existing clay ridge tiles to be temporarily removed, cleaned and re-bedded in lime mortar. Matching clay ridge tiles to be installed where new sections are required.
- R-03 Existing masonry chimney stacks to be repointed in lime mortar with lime mortar flashing to chimney tops. New matching clay chimney pots to be installed, as required.
- R-04 New cast iron rainwater goods to be installed throughout courthouse building. Profiles, dimensions and fixing brackets to match historic remnants remaining on site.

- R-05 Eaves stones in need of repair throughout.
- R-06 Concrete or cement rendered sill. Concrete to be removed to assess if stone sill remains below. Removal of concrete sill and replacement with stone sill required.
- R-07 Repair of existing stone sill required.
- R-08 Railings to be repaired in-situ. Paint to be removed throughout to facilitate inspection of the railings. Paint analysis samples to be taken. Railings to be repainted following completion of repairs.
- R-09 Exposed masonry to be repointed, consolidated and repaired prior to application of new lime render.

NOTE: Railings not shown in drawing for visual clarity purposes only.

Where repair works are noted, best practice conservation techniques will be undertaken, to include graft repairs, mortar repairs & structural reinforcement (embedded or hidden) where required.

Additional repair works may be required following full inspection from scaffolding. Indicative repairs shown for planning purposes.
