Project		Borris-in-Ossory Courthouse		Main Street, Borris-in-Ossory, Co. Laois	
Client		Laois County Council			
Drawing		South Elevations - Repairs			
Project Stage	Date	Scale	Project No.	Drawing No.	Revision
Stage 2	15/08/23	1:100@A3	0639	L-035	A

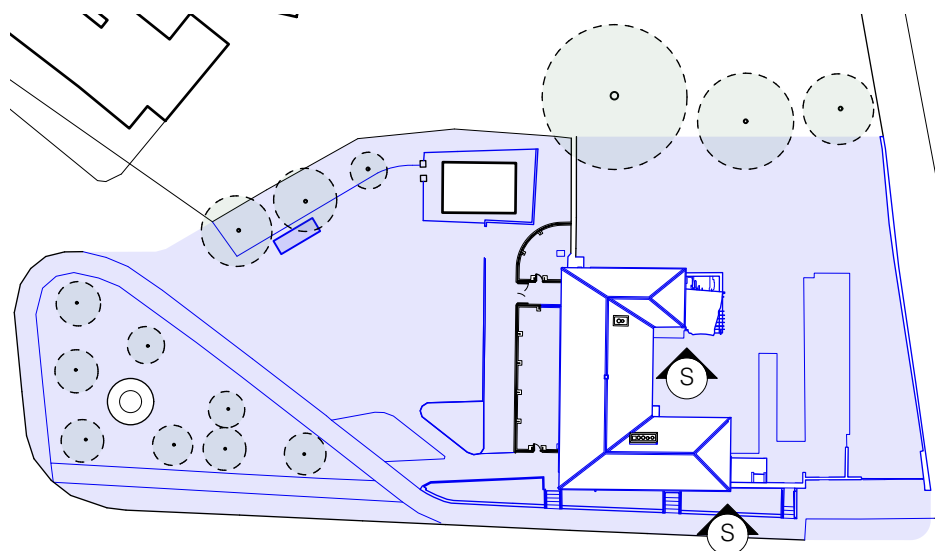
- R-01 Existing roof slates to be carefully stripped and set aside for reinstatement. Matching natural slate to be installed where new slate is required.
- R-02 Existing clay ridge tiles to be temporarily removed, cleaned and re-bedded in lime mortar. Matching clay ridge tiles to be installed where new sections are required.
- R-03 Existing masonry chimney stacks to be repointed in lime mortar with lime mortar flashing to chimney tops. New matching clay chimney pots to be installed, as required.
- R-04 New cast iron rainwater goods to be installed throughout courthouse building. Profiles, dimensions and fixing brackets to match historic remnants remaining on site.

- R-05 Eaves stones in need of repair throughout.
- R-06 Concrete or cement rendered sill. Concrete to be removed to assess if stone sill remains below. Removal of concrete sill and replacement with stone sill required.
- R-07 Repair of existing stone sill required.
- R-08 Railings to be repaired in-situ. Paint to be removed throughout to facilitate inspection of the railings. Paint analysis samples to be taken. Railings to be repainted following completion of repairs.
- R-09 Exposed masonry to be repointed, consolidated and repaired prior to application of new lime render.
