Digital Hub Borris-In-Ossory Courthouse

Design Statement and Architectural Impact Assessment

July 2023

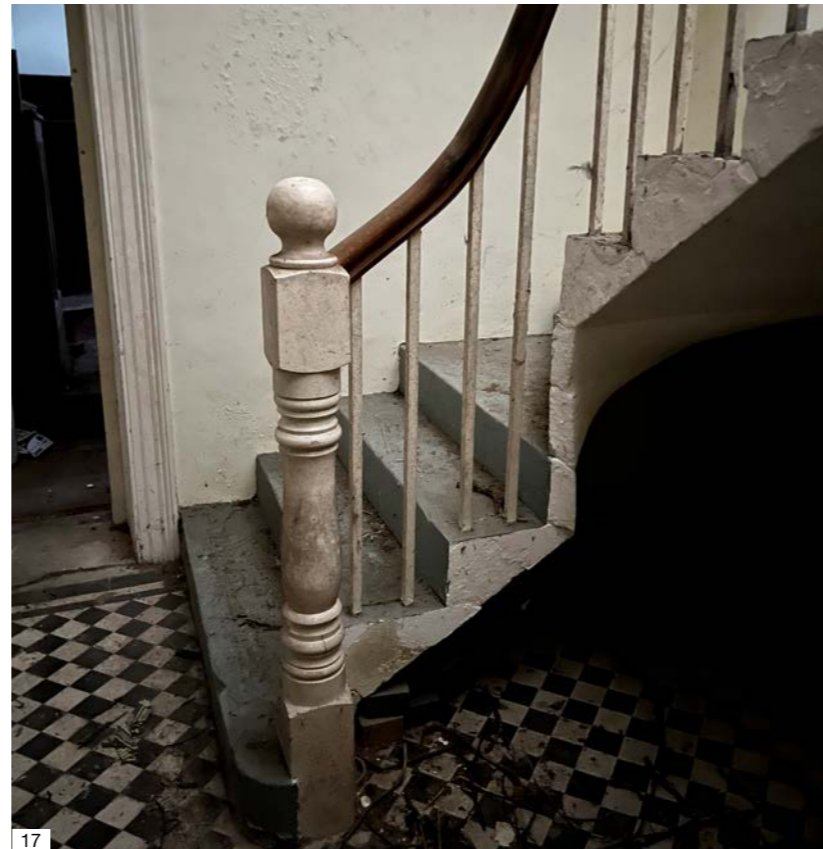
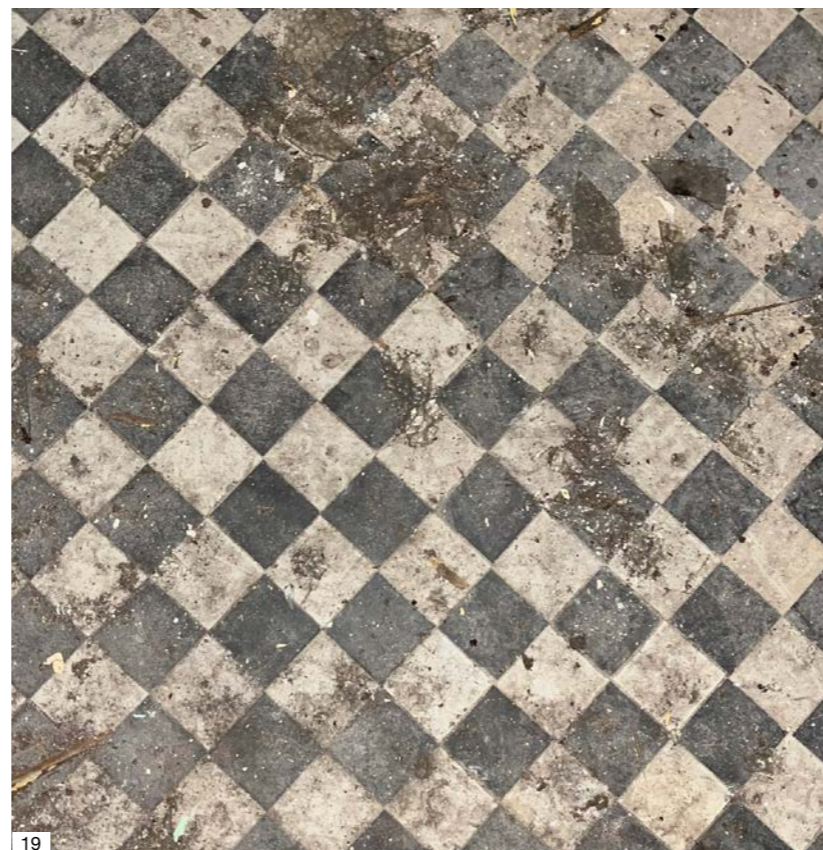
Two matching stone cantilever stairs (fig. 17, 18), which are nearly identical to the ones at Stradbally, sit behind the entrance doors on either side of the courtroom. The north stair has been modified and repaired, with the insertion of a section of concrete, but the south stair remains intact. A smaller stone and concrete stair is positioned within the south cell block wing, which would have provided direct access between the upper rooms and lower-level cells for supervision purposes. This stair is original to the building and a similar one appears in Stradbally courthouse. The balustrades are also intact on all three stairwells, and in general they are in sound and usable condition, despite a selection of obvious previous repairs.

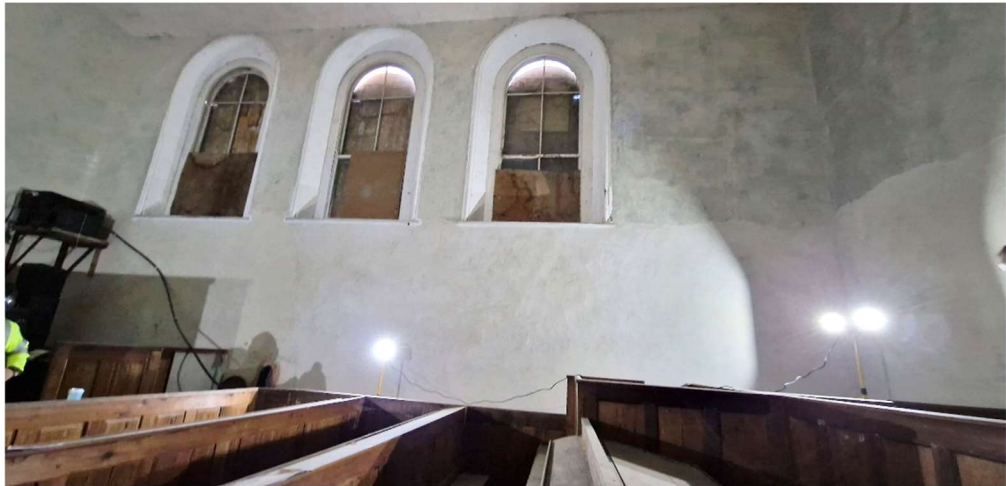
Figure 12 – Courtroom arched windows and built-in joinery

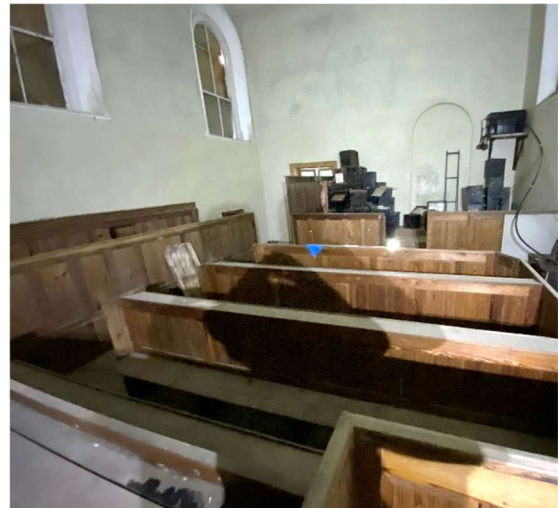
The courtroom floor is formed of timber joists and floorboards, with concrete infill between the joists. There is built-in joinery in the courtroom including seats, raised platforms, desks and screens. There is active woodworm evident throughout the floor and the joinery in the courtroom. The floorboards are soft in places and are generally in poor condition.

Figure 14 – Courtroom looking north

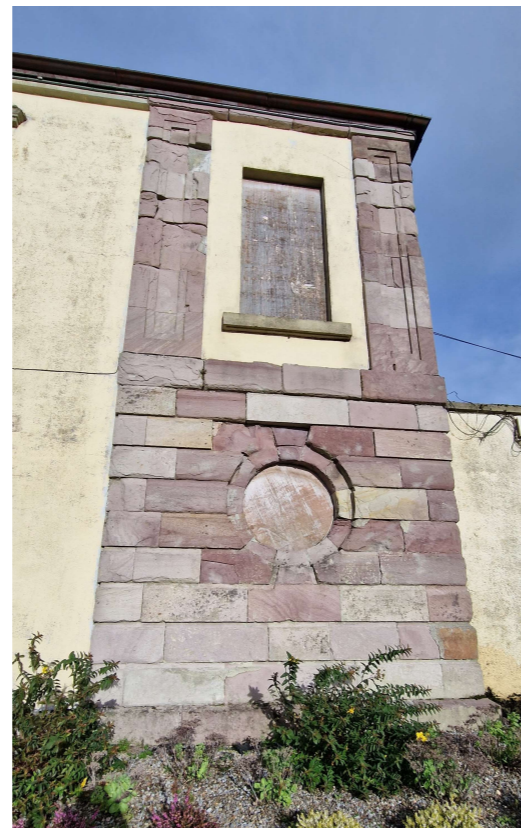
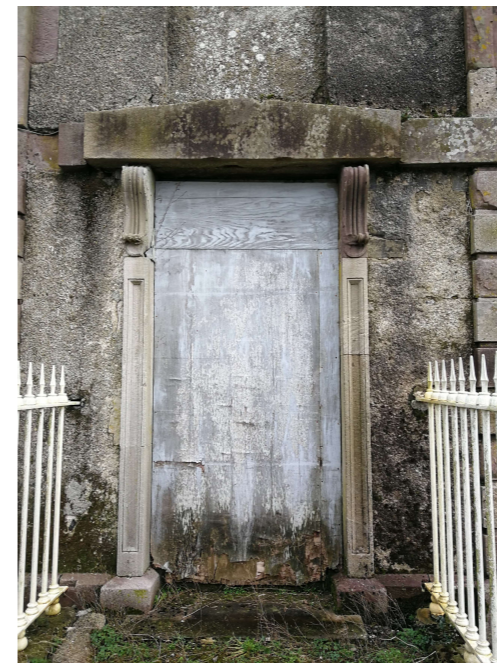
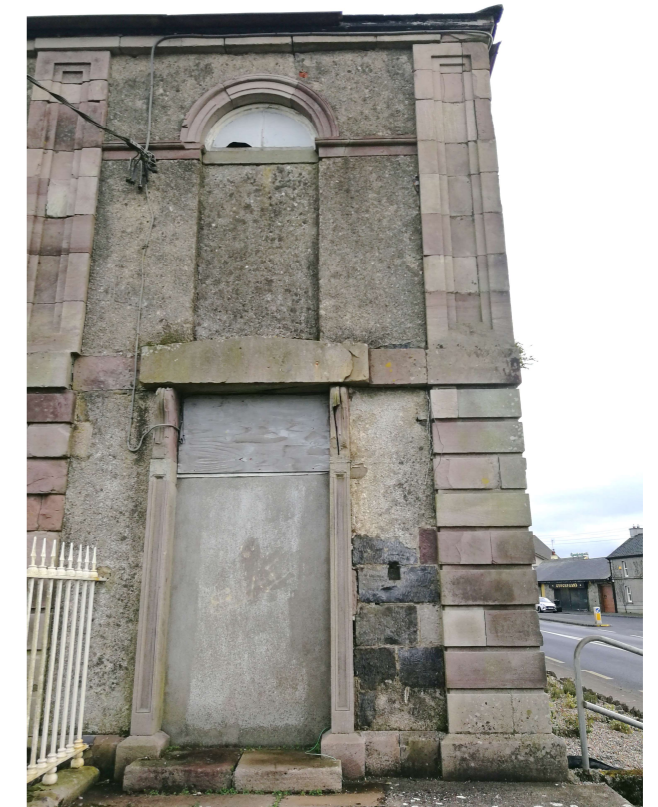
South elevation

Sandstone elements on all elevations in poor condition, requires significant replacement and repair. Includes but not limited to; eaves course, string course, wall cladding panels, lintels, decorative elements, quoins, chimneys.
